The Durability of Reinforced Concrete Structures with 35 Years of Service in Offshore Environment

Dejun Fu*

Ningbo City College of Vocational Technology, Ningbo 315000, China

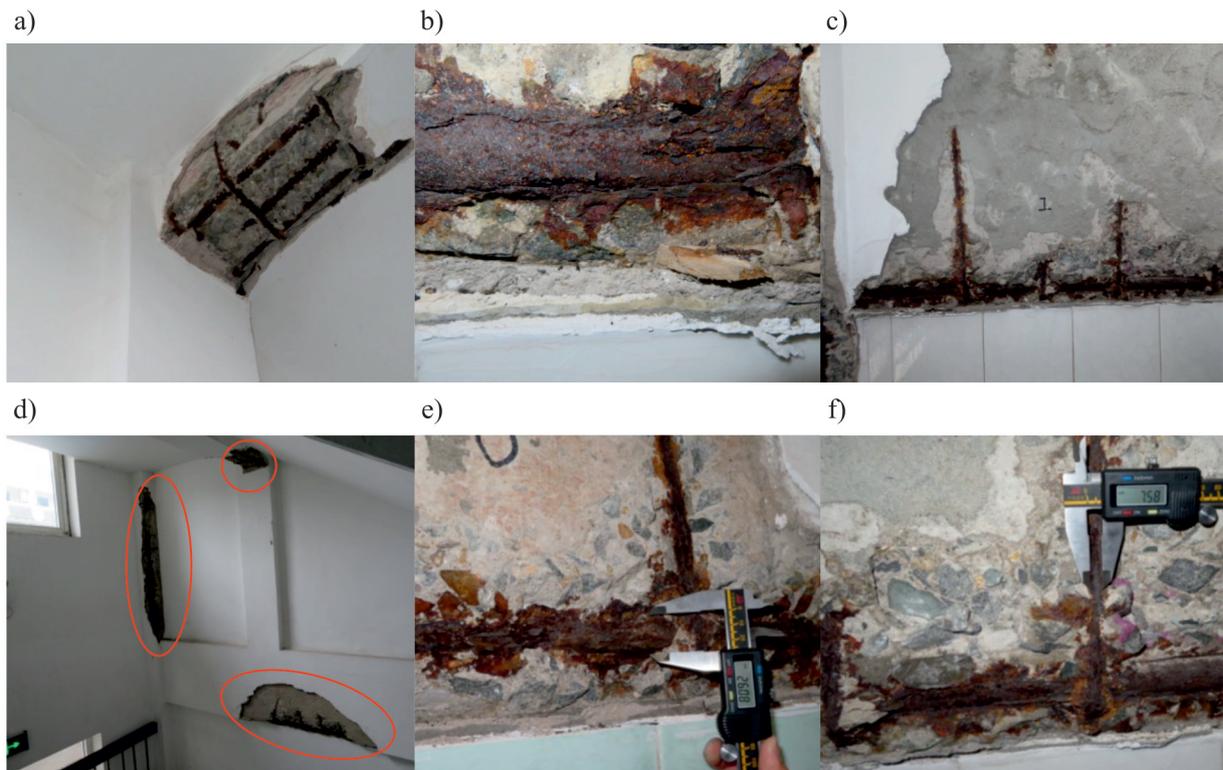
(1) Concrete members: The house is a frame structure with concrete beams and columns as the main load-bearing members. On-site inspection results demonstrated that the concrete protective layers burst and peeled off, and reinforcement bars corroded in several sites inside the house, i.e., the 2×C-E beam, 2×E column and ladder beams on the first to third floors of the west staircase, and 20×C-E beam, 20×E column on the first to fourth floors of the east staircase. Details are shown in Fig. 4. Except for part of the overhanging eaves of the north facade whose concrete was peeled off and reinforced concrete corroded, the rest of the load-bearing members were in normal service.

Fig. 4. Various conditions of steel corrosion: a) Corrosion of steel bars in the beam as a whole; b) local corrosion of steel bars; c) corrosion of longitudinal bars and stirrups in beams; d) corrosion of steel bars in beams and columns; e) diameter of longitudinal bars after corrosion; and f) diameter of stirrups corroded.

Despite minimal changes in the strength of the concrete materials, the corrosion of certain reinforcement bars within the concrete is remarkably severe. This can be attributed to the high chloride ion content in the concrete, which may be a result of using sea sand during construction or the proximity of the building to the sea. The corrosion of reinforced concrete poses safety risks to the structural members or even the entire building, necessitating special attention.

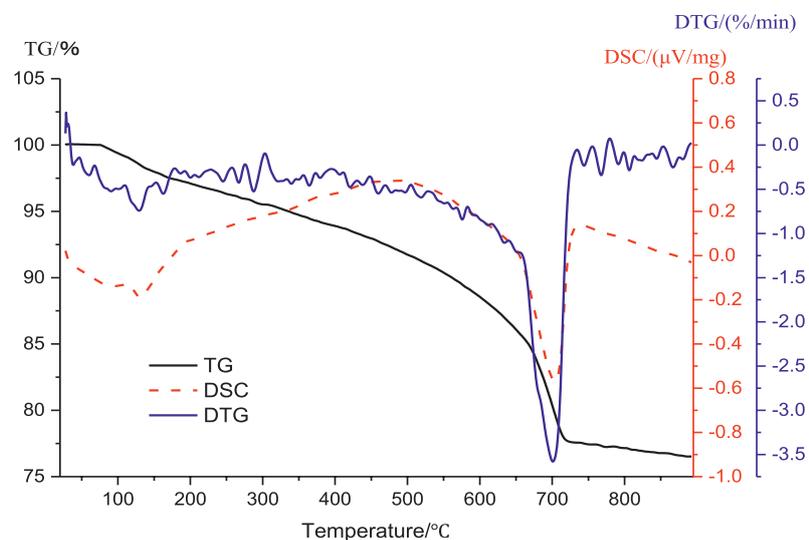
around a temperature of 100°C signaled the heat loss caused by water evaporation inside the concrete, which corresponded to the process of products of cement hydration removing free water. An endothermic peak around 680°C represented the decomposition of CaCO_3 , and the mass loss embodied the release of CO_2 . No obvious trough in the TG-DSC curve around 430°C meant no Ca(OH)_2 in the concrete. Detailed results are shown in Fig. 5.

Fig. 5. TG-DSC curve of concrete powder.

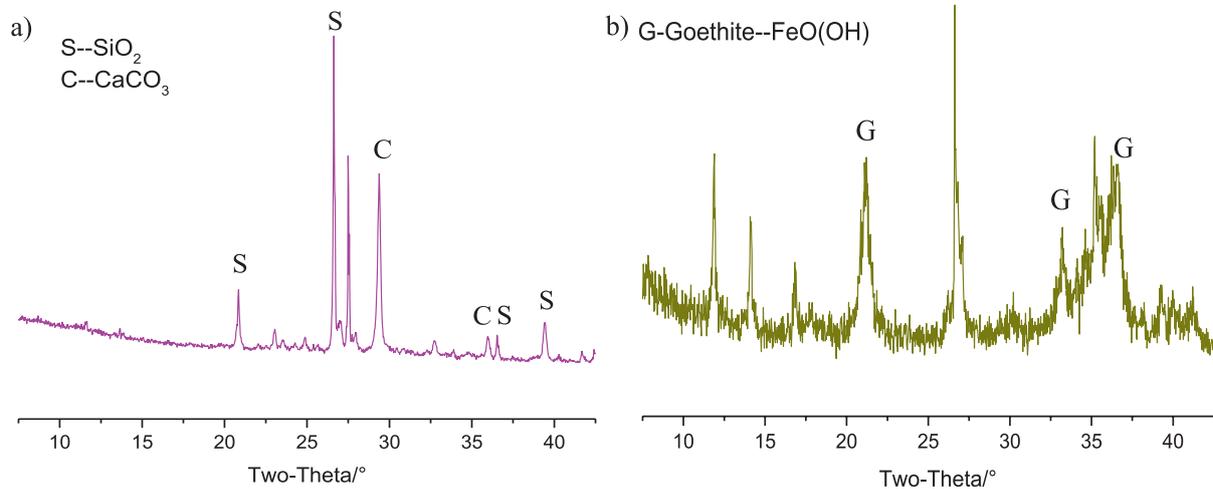
The results gained through XRD analysis also supported the above argument that no Ca(OH)_2 existed in the concrete. Ca(OH)_2 in the concrete was carbonized into CaCO_3 after over 30 years. XRD results in Fig. 6a) illustrated that the chemical composition of concrete materials was mainly SiO_2 and CaCO_3 , and results in Fig. 6b) demonstrated that the main composition of the corroded reinforced concrete powder was rust.

Fig. 6. XRD pattern: a) Concrete powder; and b) corrosion steel powder.

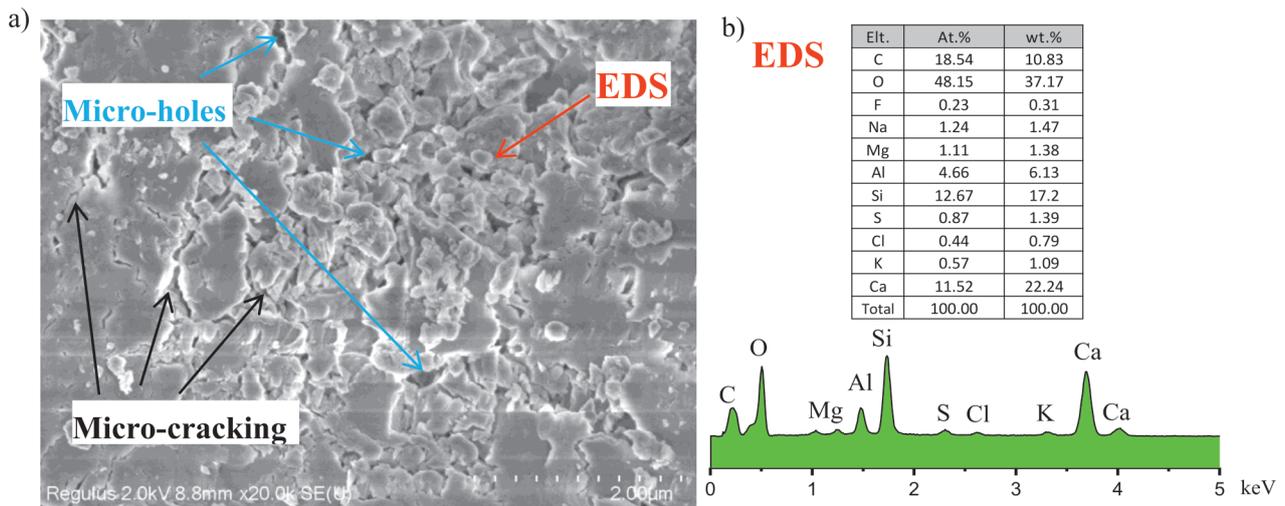
A micro detection of the appearance of concrete samples was conducted with a scanning electron microscope and it's discovered that there were many micro-cracks and holes on the surface of the concrete samples, and the concrete was partially loose, which may affect the strength of the concrete. Moreover, besides C-S-H gel elements, such as Ca, Si and O, other elements like Al, C, Mg, S, Cl were also discovered in the local area of the concrete samples by virtue of energy spectrometer. The results are shown in Fig. 7.

Fig. 7. a) SEM images of concrete; and b) energy spectrogram.
