# The Durability of Reinforced Concrete Structures with 35 Years of Service in Offshore Environment

Dejun Fu\*

Ningbo City College of Vocational Technology, Ningbo 315000, China

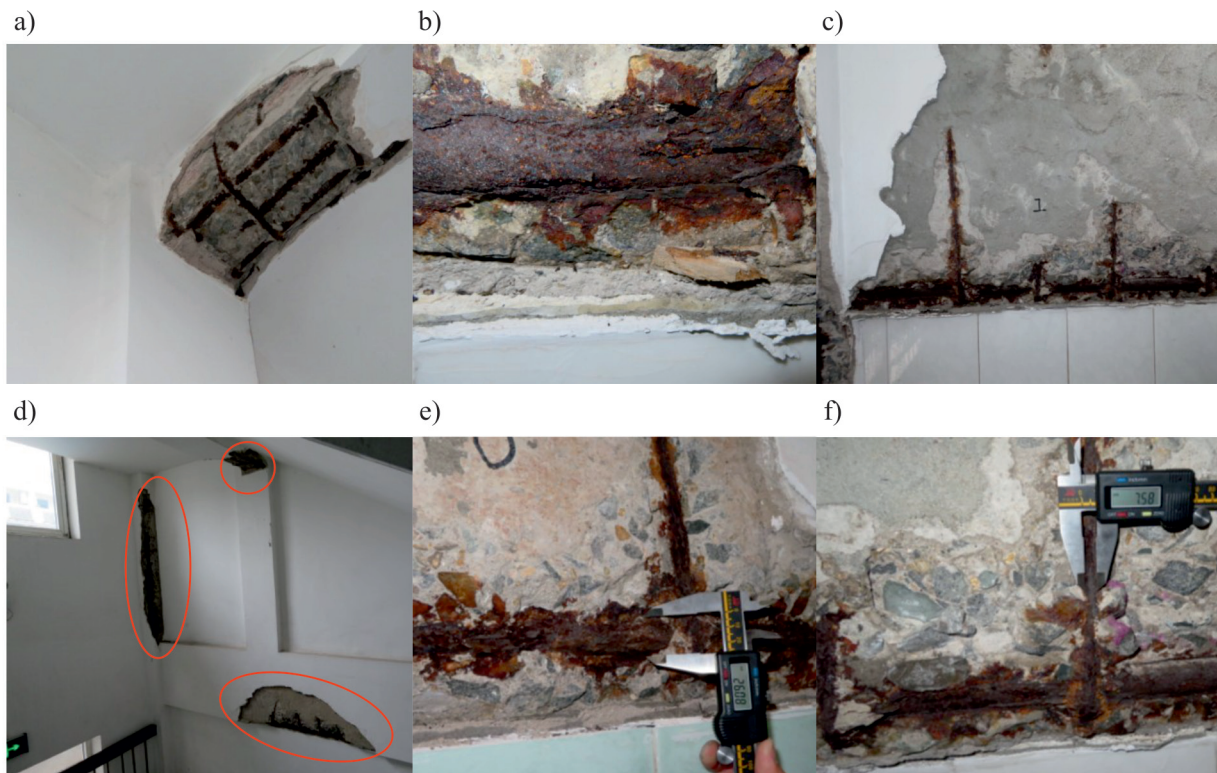
(1) Concrete members: The house is a frame structure with concrete beams and columns as the main load-bearing members. On-site inspection results demonstrated that the concrete protective layers burst and peeled off, and reinforcement bars corroded in several sites inside the house, i.e., the 2×C-E beam, 2×E column and ladder beams on the first to third floors of the west staircase, and 20×C-E beam, 20×E column on the first to fourth floors of the east staircase. Details are shown in Fig. 4. Except for part of the overhanging eaves of the north facade whose concrete was peeled off and reinforced concrete corroded, the rest of the load-bearing members were in normal service.

Fig. 4. Various conditions of steel corrosion: a) Corrosion of steel bars in the beam as a whole; b) local corrosion of steel bars; c) corrosion of longitudinal bars and stirrups in beams; d) corrosion of steel bars in beams and columns; e) diameter of longitudinal bars after corrosion; and f) diameter of stirrups corroded.

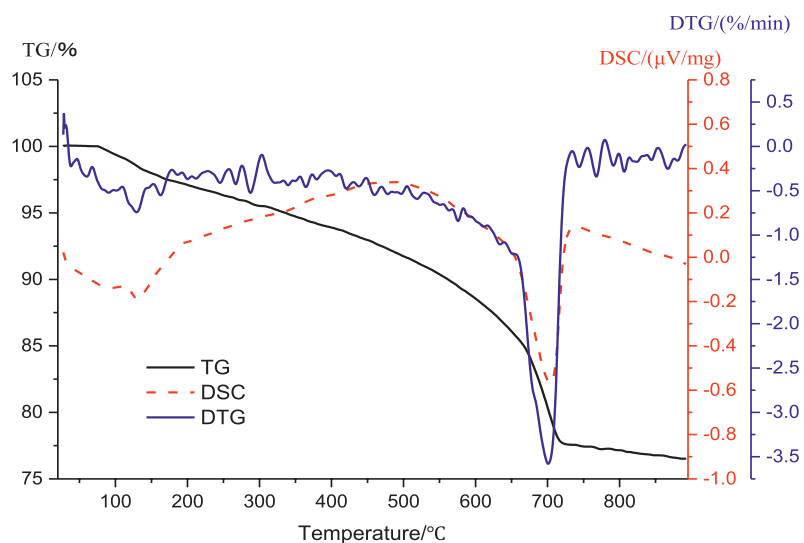
According to the results of the simultaneous thermal analysis (STA) of concrete powder, the trough

around a temperature of 100°C signaled the heat loss caused by water evaporation inside the concrete, which corresponded to the process of products of cement hydration removing free water. An endothermic peak around 680°C represented the decomposition of  $\text{CaCO}_3$ , and the mass loss embodied the release of  $\text{CO}_2$ . No obvious trough in the TG-DSC curve around 430°C meant no  $\text{Ca(OH)}_2$  in the concrete. Detailed results are shown in Fig. 5.

Fig. 5. TG-DSC curve of concrete powder.

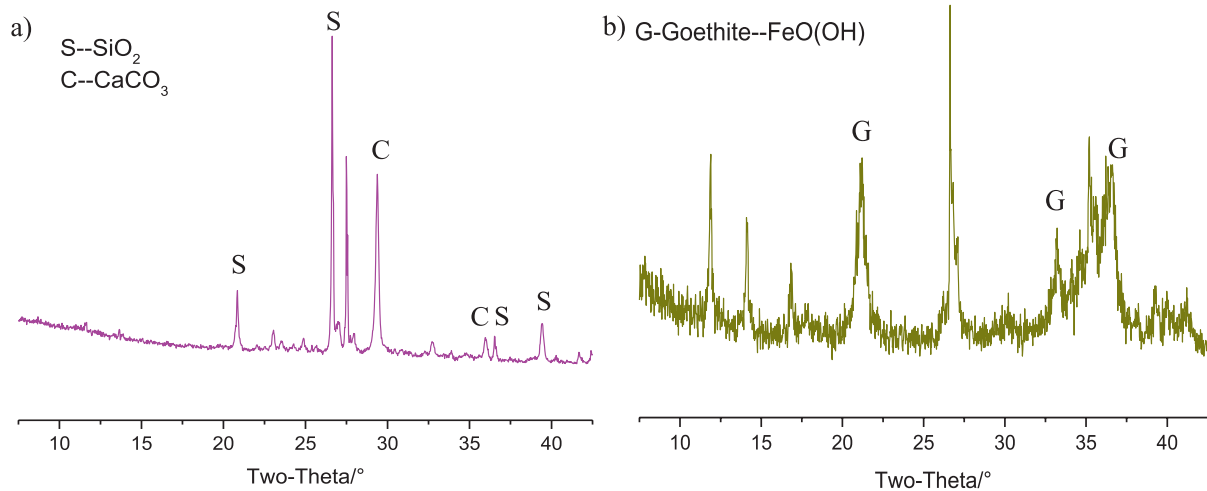
The results gained through XRD analysis also supported the above argument that no  $\text{Ca(OH)}_2$  existed in the concrete.  $\text{Ca(OH)}_2$  in the concrete was carbonized into  $\text{CaCO}_3$  after over 30 years. XRD results in Fig. 6a) illustrated that the chemical composition of concrete materials was mainly  $\text{SiO}_2$  and  $\text{CaCO}_3$ , and results in Fig. 6b) demonstrated that the main composition of the corroded reinforced concrete powder was rust.

Fig. 6. XRD pattern: a) Concrete powder; and b) corrosion steel powder.

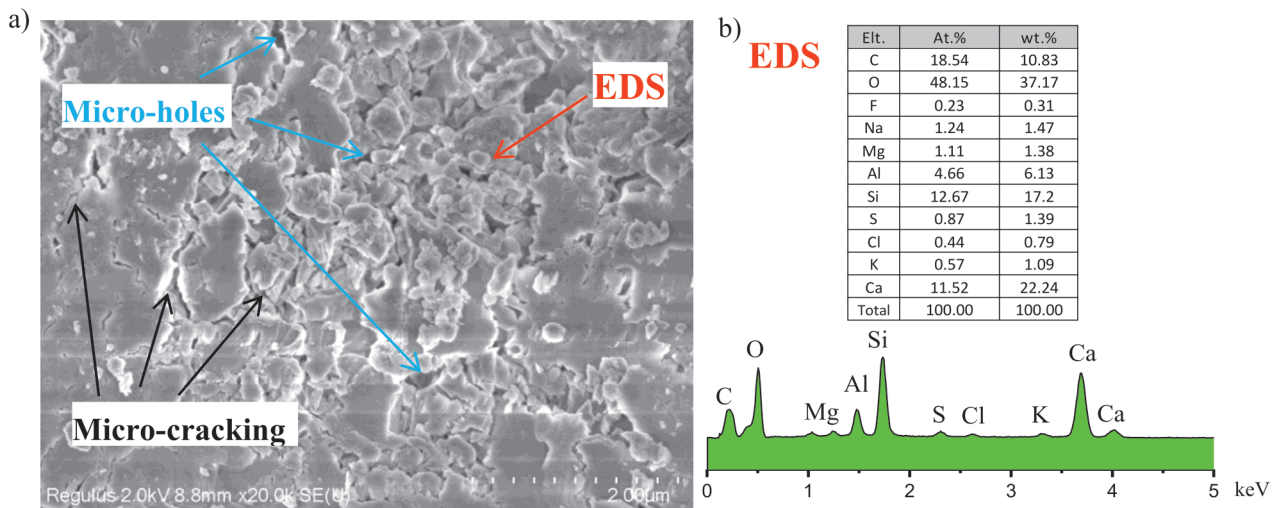
A micro detection of the appearance of concrete samples was conducted with a scanning electron microscope and it's discovered that there were many micro-cracks and holes on the surface of the concrete samples, and the concrete was partially loose, which may affect the strength of the concrete. Moreover, besides C-S-H gel elements, such as Ca, Si and O, other elements like Al, C, Mg, S, Cl were also discovered in the local area of the concrete samples by virtue of energy spectrometer. The results are shown in Fig. 7.

Fig. 7. a) SEM images of concrete; and b) energy spectrogram.
