Impacts and Recovery from a Large Tsunami: Coasts of Aceh

P. P. Wong*

Department of Geography, National University of Singapore, 1 Arts Link,
Singapore 117570, Singapore

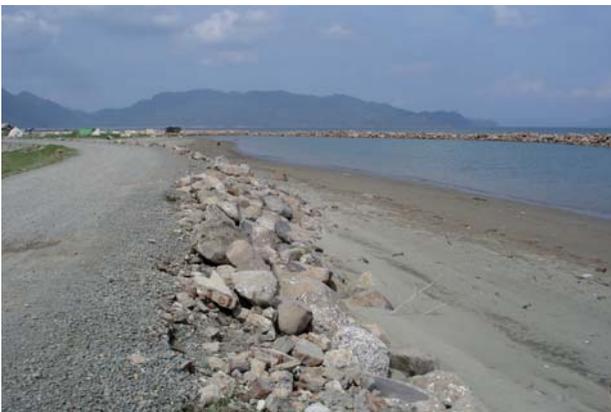
Fig. 2. Deah Geulumpang Beach in its early stage of recovery ceased to recover further when enclosed behind a rubble seawall that stretches from the east of the town to the Alue Naga Floodway Channel, March 2007.

The structure prevented beach formation outside the wall as observed at Krueng Bau (east of Lam Badeuk). A small sandy tombolo between a remnant terrain and the seawall was evident in March 2007 but it disappeared when observed in August 2008. Deah Geulumpang beach could not recover further with the completion of seawall when observed in August 2006 (Fig. 2).

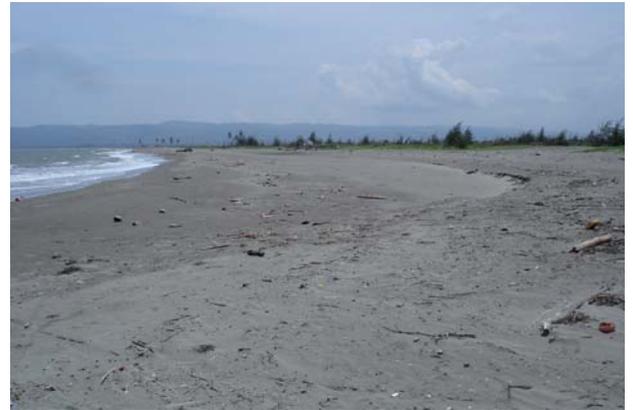
Fig. 3. Kahjue Beach, east of the Alue Naga Floodway Channel, continues to recover as it is not enclosed by the rubble seawall, March 2007.

Immediately east of the Alue Naga Floodway Channel is Kahjue Beach, which is an example of a beach where coastal processes operate without the interference of the seawall. It benefited from the movement of onshore material and longshore drift from east to west (Fig. 3). Further to the east at Lam Bada Beach, foredunes of almost 1m in height have formed as a result of more sediments and strong wind from the Northeast Monsoon (Fig. 4). The foredunes are colonized by a herbaceous herb *Sesuvium portulacastrum* and a sand-binding creeper *Ipomoea pes-caprae*.

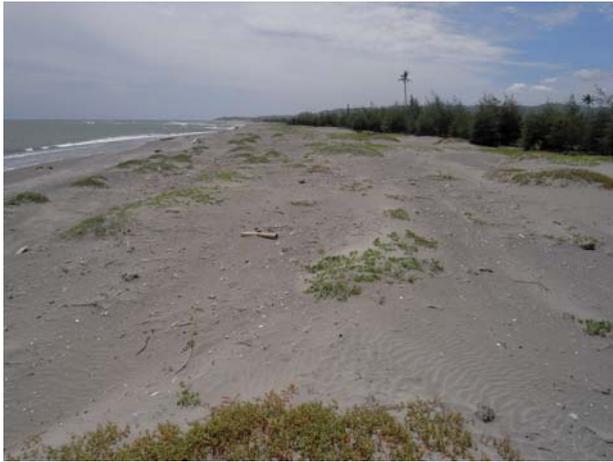
Fig. 4. The recovery of Lam Bada Beach has progressed well with the formation of low foredunes colonized by *Sesuvium portulacastrum* (foreground) and *Ipomoea pes-caprae*, August 2008. Landwards of the foredunes are planted Casuarinas.

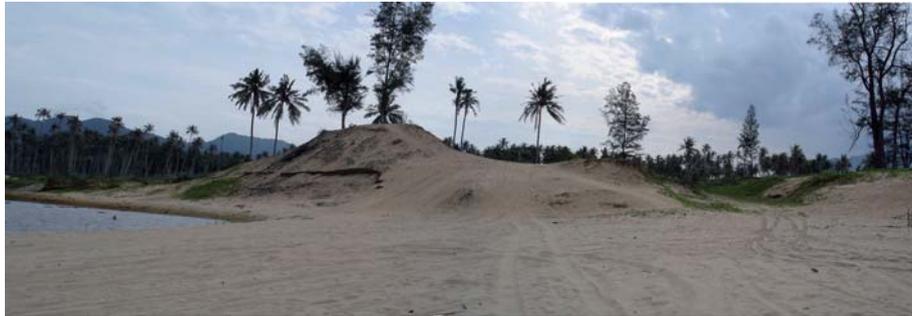
Fig. 5. The high coastal dune belt at Lampuuk was eroded and scoured severely to expose underlying layers of fossilized layers, August 2008.

Lampuuk beach with its 15-m high dunes was affected severely. Sand was removed inland and offshore and the tsunami waves penetrated into the river on the northern end of the beach. The beach ridges and dunes were stripped of vegetation and lowered in height; the overlying material of the dunes removed to expose underlying cemented layers, also noted in an earlier study [11] (Fig. 5). While the beach ridges and dunes could not regain their height, the beach recovered rapidly and its backshore planted with casuarinas. Further inland, the tsunami-flooded area is being reduced (Fig. 6). The stream near the northern headland is still blocked by a sand bar.

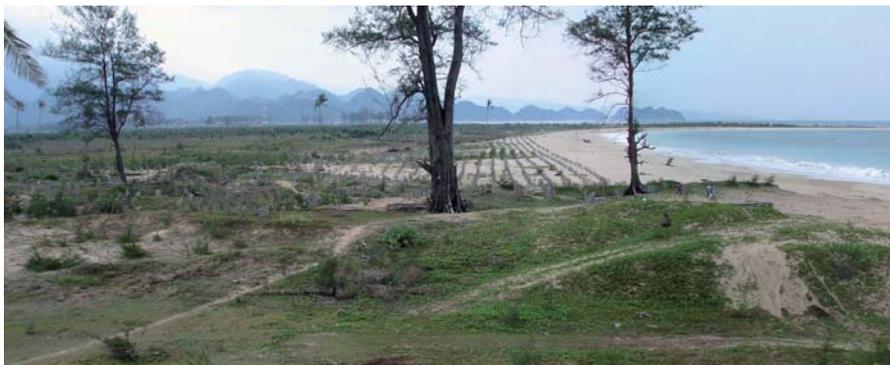
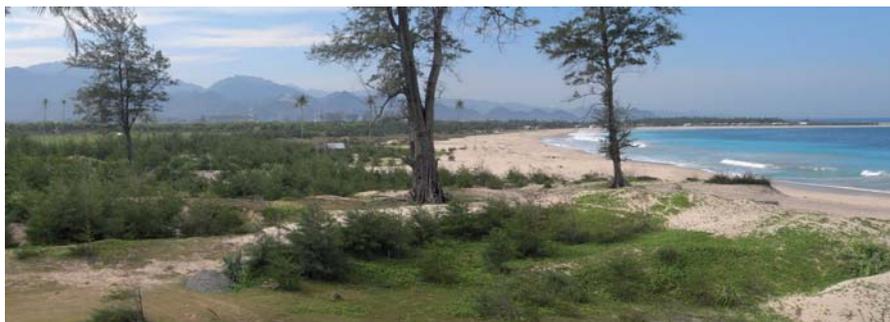
Fig. 6. As Lampuuk Beach recovered, casuarinas were planted on the backshore in rows parallel to the shoreline, March 2007 (a). Some of the more seaward rows did not survive but the rest flourished well, August 2008 (b).

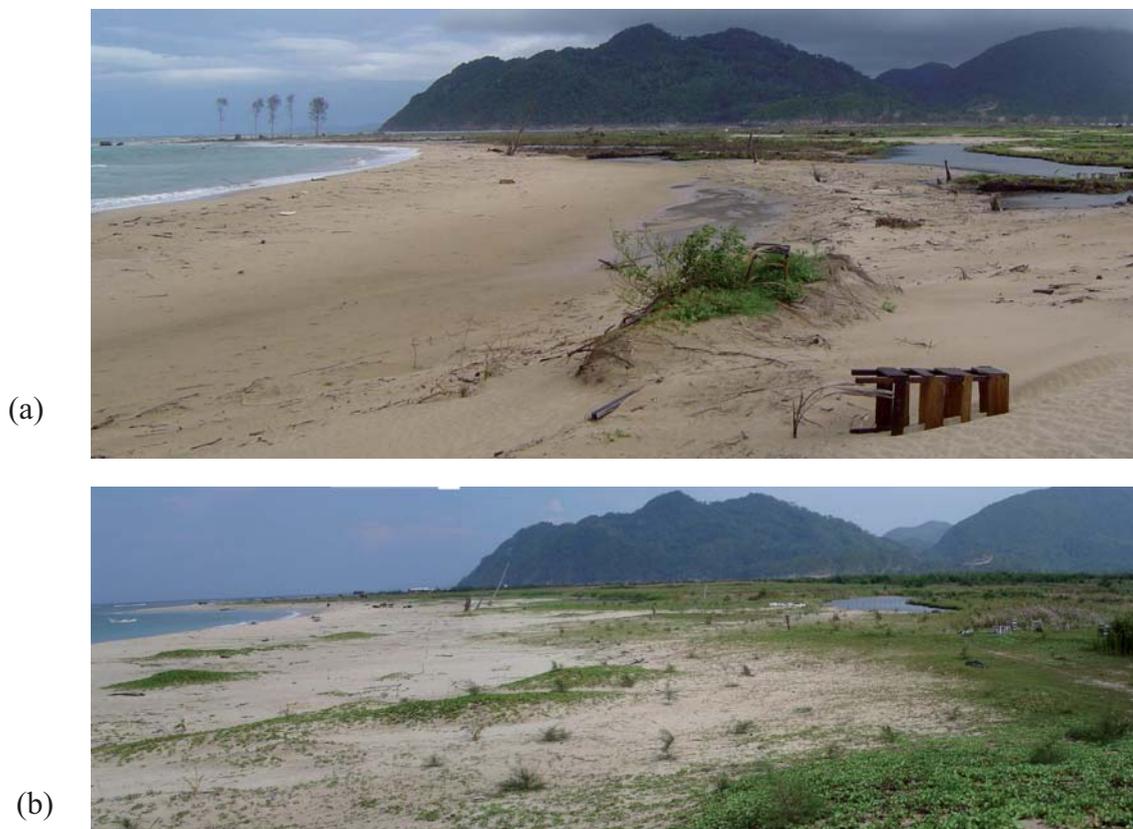
Fig. 7. In May 2005, Lhok Nga Beach was in an early stage of recovery with sand moving landward to reduce the depression and the flooded area (a). By March 2007 the flooded area has been greatly reduced, the beach well recovered and low foredunes formed (b).

Another indication of rapid coastal recovery is immediately south of Lampuuk at Lhok Nga beach, where there were low dunes before the tsunami. The beach has recovered through the migration of bars welded to the beach to reduce the depression on land. Foredunes have re-established due to strong winds from the southwest (Fig. 7).

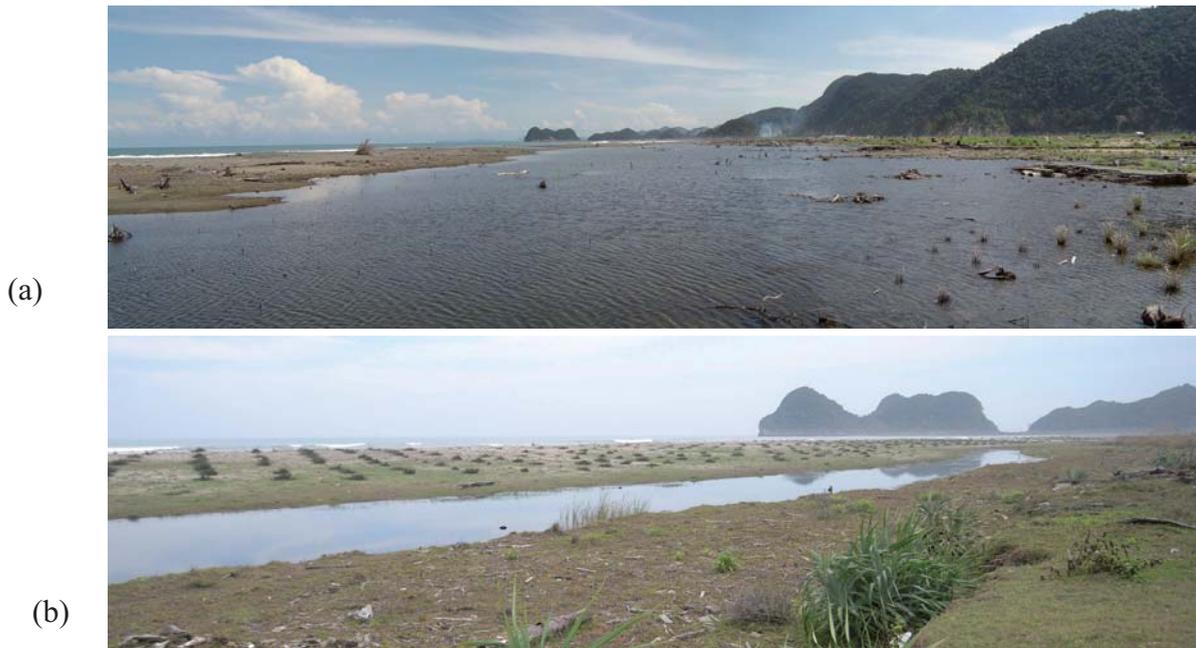
Fig. 8. In May 2005, the barrier at Leupueng was barely recovering with the lagoon remaining wide (a). By Aug 2008, the lagoon had decreased its width and the barrier had widened and was planted with casuarinas (b).

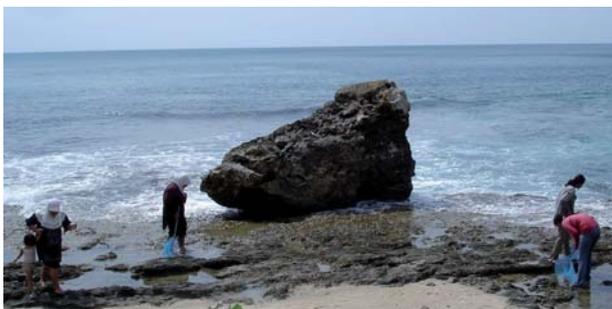
Fig. 9. The largest boulder reported in this study has fresh (whitish) marks indicating that it was clearly dislodged and moved to the coral flat by the tsunami waves, March 2007.

an estimated 85 tons [11]. In May 2005 the largest coral boulder measured about 1x2x3m and estimated around 15.6-16.2 tons assuming that the specific gravity of coral is below that of limestone at 2.6-2.7 (Fig. 9). This boulder had been dislodged from the reef flat and has not moved from its position.

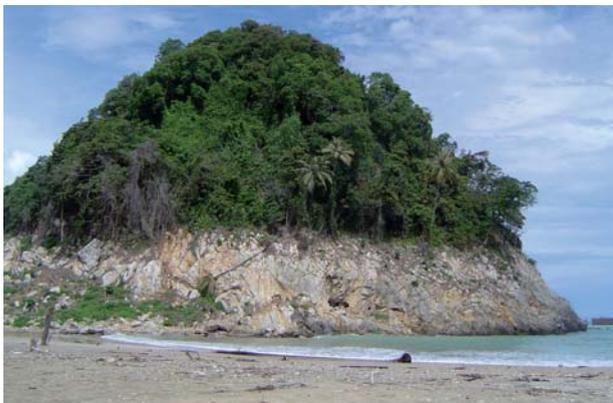
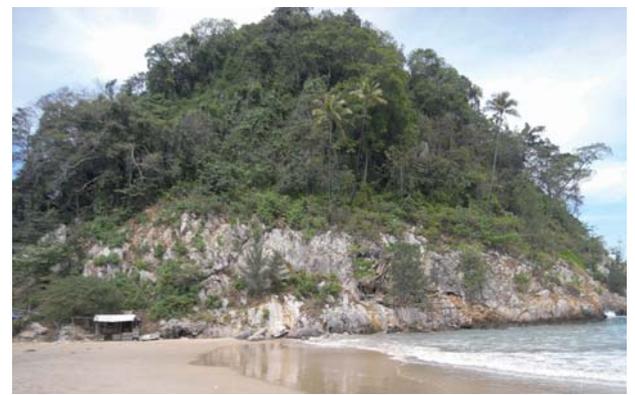
Fig. 10. The hill north of the harbour on the West Coast showed its characteristic trimline, May 2005 (a). By August 2008, vegetation had re-established at the trimline to make it less distinctive.

The tremendous force of the tsunami waves is evident on rocky headlands which took the full force as the tsunami hit the coast. Basal stripping of the forested slope produced a distinct and characteristic trimline in the headlands. I propose to name this type of headland as the “Dayak” headland, after the coiffure of the Dayaks (a general term referring to the indigenous non-Muslim groups in Kalimantan/ Borneo) (Fig. 10). This “Dayak” headland does not correspond to any existing model of hardrock headland in which the vegetation cover has an important role [33]. Laser measurements of the headland immediately north of the harbour indicated the trimline to be at 20.5m, compared to 25m in another study [44].

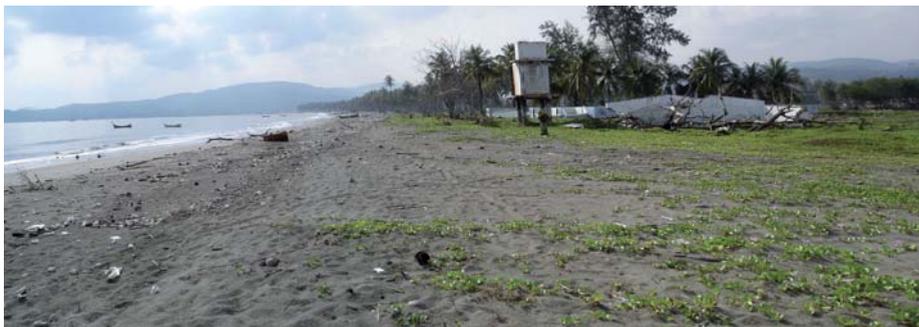
Fig. 11. South of Uteuen Ranub, beach recovery is still in progress and is also affected by seasonal changes, March 2007.

Coastal recovery began particularly with the onset of the Northeast Monsoon towards the end of 2006. Although the low dunes and beach ridges were eroded, coastal recovery took place along the entire East Coast. The main process of recovery is in the landward movement of nearshore material, leading to the gradual disappearance of the elongated depression as materials were added to the tsunami-impacted sandy coast (Fig. 11). At Kuala Lho Me, the beach ridge had been eroded and with subsidence, the *Sonneratia alba*, are now in a much seaward position. The beach is recovering as sediments are brought down to the coast by the stream (Fig. 12).

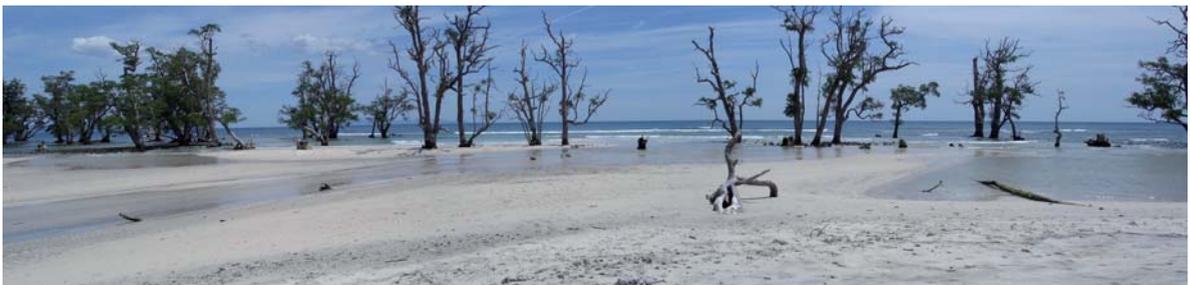
Fig. 12. At Kuala Lho Me, subsidence has resulted in mature *Sonneratia alba* lying 40-100m from the shoreline at high tide. The beach is recovering from sand brought down by a stream from a coastal sector where active rehabilitation of the coast for shrimp ponds is taking place, August 2006.

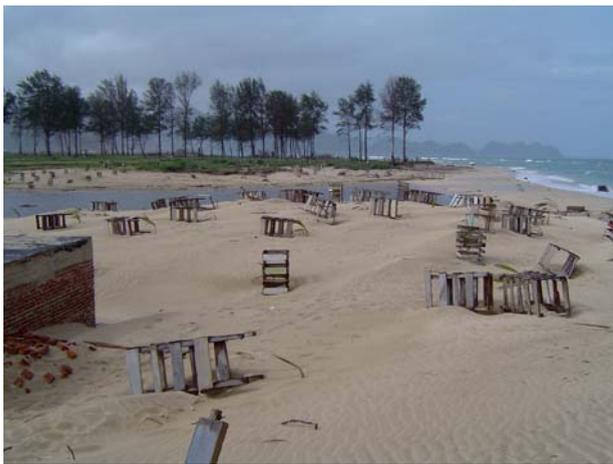
Fig. 13. An early attempt to plant coconuts at the Lumpuuk dunes failed because of burial from sand, May 2005.

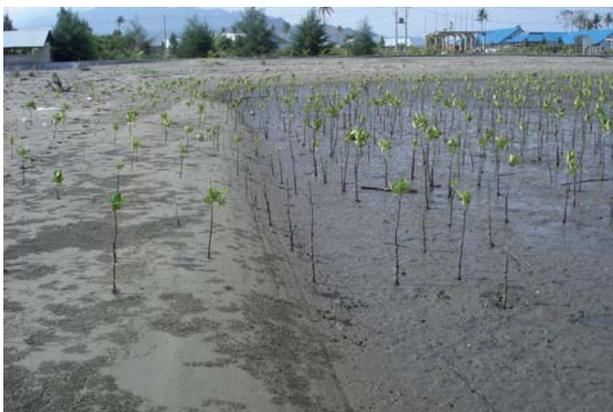
Fig. 14. At Krueng Bau, replanted mangroves faced problems of sedimentation and barnacle infestation, March 2007.

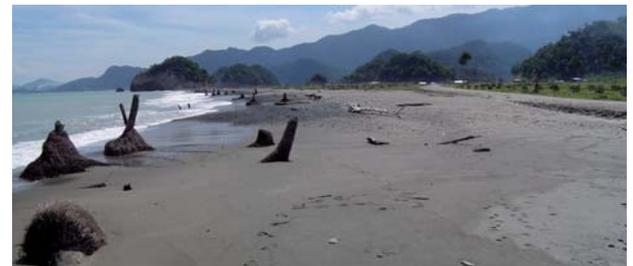
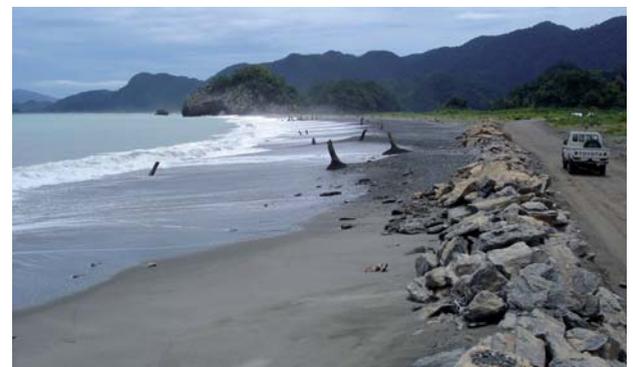
Fig. 15. Remaining coconut tree stumps were indicative of severe erosion to the coast at Pulot village, May 2005 (a). By August 2006, a rubble seawall had been built to protect the road which was occasionally affected by high tides (b).

Seawall construction to protect the eroded coast in the post-tsunami phase is questionable in some cases. On coasts where subsidence has occurred and flooding is common, seawalls to prevent flooding (with complementary flood alleviation schemes) seems logical, such as at Pulot village on the West Coast (Fig. 15). However, where beach recovery is evident and the beach is wide enough to protect the coast, there is less necessity for a seawall, such as south of Ujung Riteng, where the seawall approaches the base of the headland (Fig. 16), and north of the cement plant at

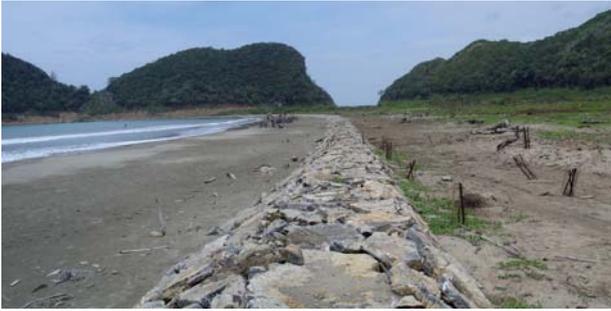
Fig. 16. South of Ujung Riteng, the beach is recovering and wide enough for protecting the road. A rubble seawall constructed up the headland in the south is unnecessary and interferes with beach recovery, March 2007.

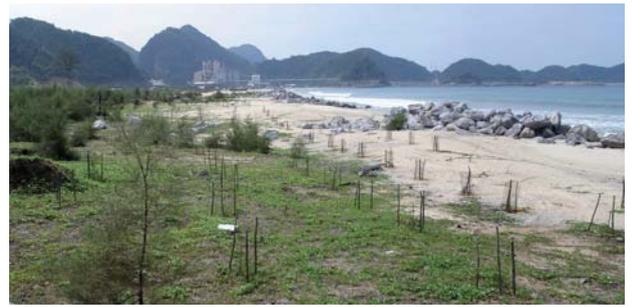
Fig. 17. North of the cement plant, Pasijalang Beach has recovered well enough to have casuarinas planted on its backshore and is used for local recreation. The construction of a rubble seawall almost along the berm crest would not be useful, March 2007.

Pasijalang (Fig. 17). In August 2006, the beach at Pasijalang had a 47-m berm colonized by *Ipomoea pes-caprae* and has replanted coconuts. Although the rubble seawall on the North Coast was meant to keep out high tides and floods, it restricts the discharge of floodwater and seawater. An alternative protective barrier could be provided by the rehabilitation of mangroves and other coastal vegetation [36].
