# Geomorphology and Superficial Bottom Sediments of Khao Lak Coastal Area (SW Thailand)

I. Di Geronimo<sup>1\*</sup>, M. Choowong<sup>2</sup>, S. Phantuwongraj<sup>2</sup>

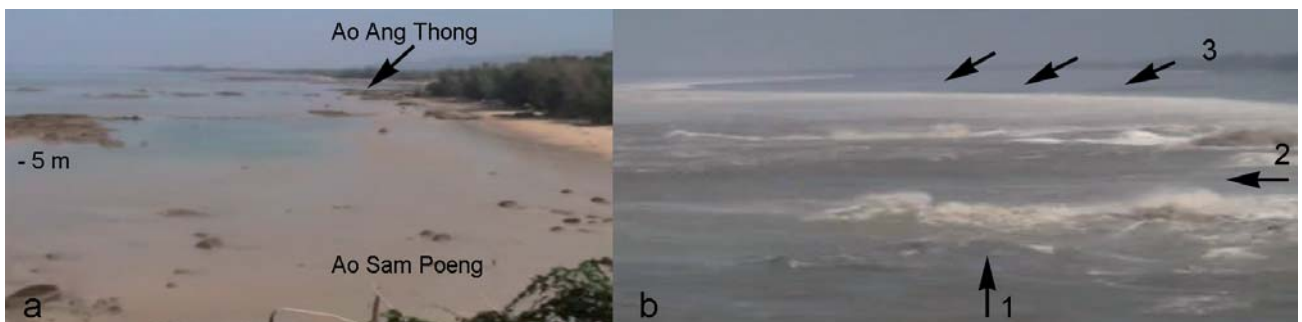
Fig. 1. Arrival of 26 December 2004 tsunami to the Khao Lak coast. Pictures from a eyewitness personal video at Laem Hin Chang. a) Withdrawal of the first depression wave at approximately 10:15 a.m. b) Just after the arrival of the first wave, approximately 10:22 a.m. 1) refracted wave from Laem Hin Chang northern side, 2) backwash from Ao Sam Poeng, 3) The front of first wave still not arrived to the Ban Bang Niang and Laem Pakarang coast, owing the bottom morphology and lithology.

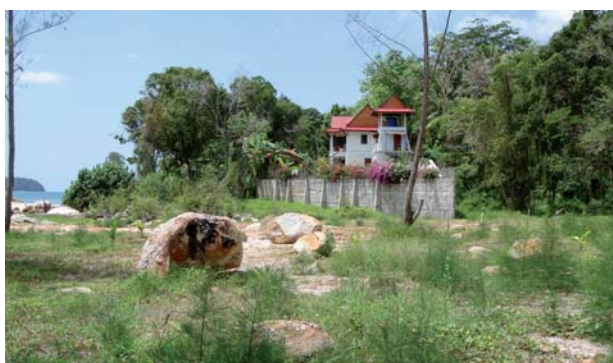
Fig. 5. Poseidon Resort at Khao Lak in February 2006. Alignment of granite blocks moved by tsunami up to 150 m inland.

At Laem Pakarang, on the tidal reef flat and along the reef slope until the base, there are hundreds of reef blocks of several tons weight, and uprooted big coral colonies moved by tsunami waves [7, 20] (Fig. 4c, d). The blocks are located in the middle and in the proximal tidal flat area; some scattered mega-blocks lie very close to the coastline. Other several ton granite blocks were moved by tsunami till 150 m inland, at Poseidon Resort [3] (Fig. 5).

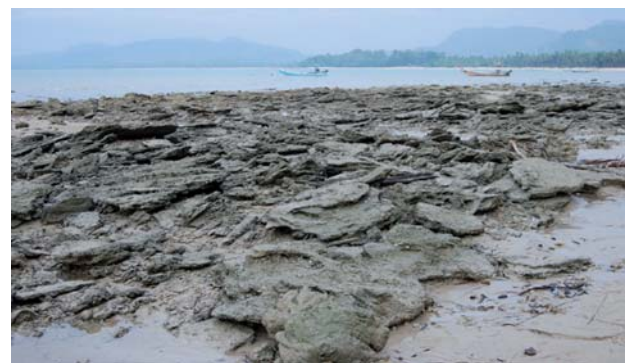
Fig. 6. Beachrock slabs moved by tsunami at Ao Po, northern side of Laem Pakarang. The slabs are largely exposed during low tide. March 2008.

On the Pakarang northern side, at Ao Po, 1km long and 200 metres out is a large strip of Holocene beachrock (Fig. 2, 6).

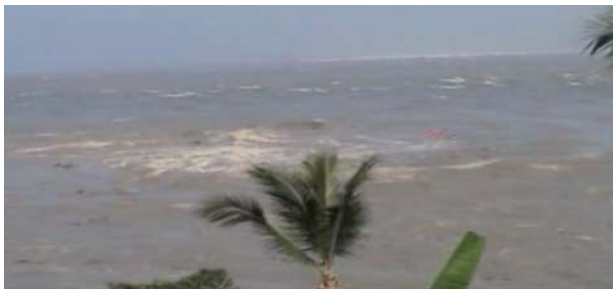
Fig. 7. Vortex formed at sea, northwest of Laem Hin Chang, by 26 December 2004 tsunami. Picture from eyewitness personal video at approximately 10:26 a.m.

The two unusual black anoxic pure mud patches northwest of Laem Hin Chang (Fig. 2) are supposed to be temporary. The origin of these shallow water open sea face exceptional mud accumulations is two persistent big vortices by the 26 December 2004 tsunami (Figs. 3B, 7) and by the relevant suspension.

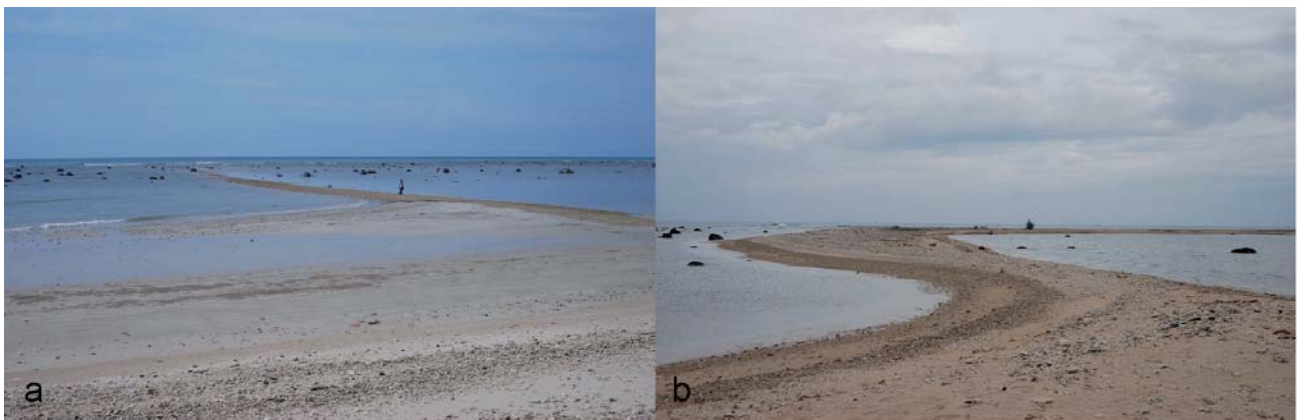
Fig. 8. Two coral sand-rubble bars along the southern side of Laem Pakarang, at low tide. The smaller one (a), not in the map, is located 300 m southeast of the bigger one (b).

A large amount of marine sand with a low percentage of pebbles, shells and forams was eroded by tsunami waves from the coastal bottoms, not deeper than 5-6 m, and from the beach, and then quickly deposited on land with generally 2 layers 0-30cm thick [4]. A large amount of white coral sand and rubble, however, was deposited on Pakarang tidal flat (Fig. 4b) and on the Ao Po bay after destroying and passing over the cape. This coral sand and rubble was later moved and pushed back to the coast by the return flow; along the coast, and then possibly moved to the north by the littoral drift. Now the Pakarang tidal reef flat, nearly free of sand and coral rubble, shows many areas of the former erosional surface riddled with endobiont organism perforations (Fig. 4e, f). Moreover, around Pakarang 4 evolving sand-rubble bars are presently formed. The larger and longer bar is formed by the northern sediments moved by the littoral drift, in the same place were the Pakarang terminal stretch was swept away by the tsunami. The other three bars are likely formed by the present wave refractions (Fig. 8).
