# Floodplain Forest Technical and Monitoring Solutions for Protection of the Uroczysko Warta Floodplain Forest

**Keywords:** floodplain forests, hydrological regime changes, floodplain forest protection technical solutions

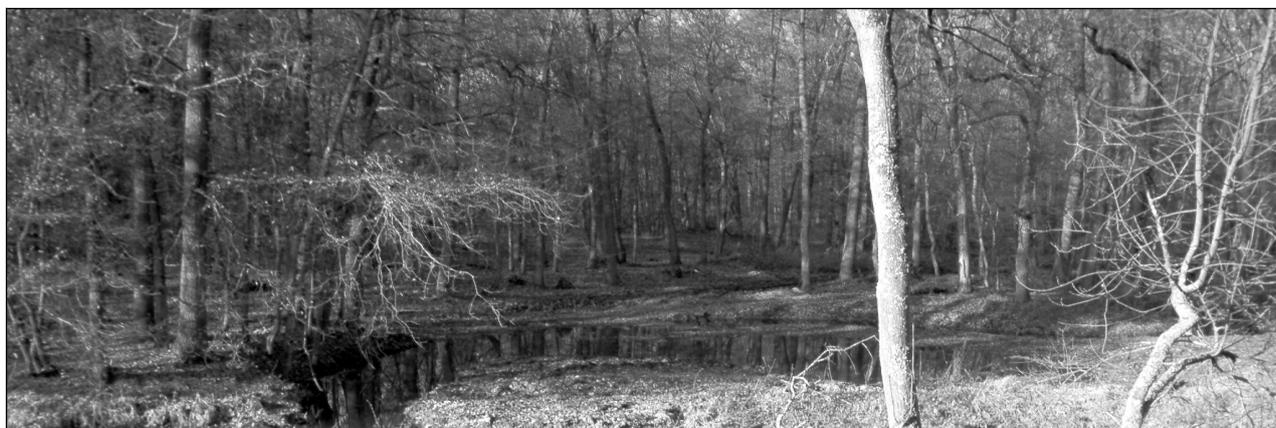
a)

ses were completed in order to work out optimal technical solutions. Founding of the supplementary project was provided by a grant won from the EcoFound (EkoFundusz) Foundation. The planned project is titled “Protection of floodplain ecosystems of Uroczyisko Warta Forest in Żerkowsko-Czeszewski Landscape Park – the second stage;” and was scheduled for technical implementation 2009 to 2010. Dedicated technical solutions were selected in order to enlarge the environmental intervention area to neighboring floodplain areas of Dębno and Warta Forests. Altogether, the area under environmental intervention covered 1500 ha. The supplementary water system is composed of 3 converted flap valve culverts (Fig. 3b). The reconstruction of flap valve culverts included the addition at the top of embankment flashboard gates for control of water overflow. Other technical elements of the system form 2 damming new-constructed sills and a rebuilt river sill on the Lutynia River (originally built in 2005, Fig. 3c). Transfer of stored water between oxbow lakes and the main river channel was provided by a system of dry channels created in landed oxbow lakes, which form a sequence of linear depressions. These depressions were connected, if necessary, by ditches to form a coherent water transfer system. The dry channels are provided with additional regulating flashboard gates for the control of stored water outflow.

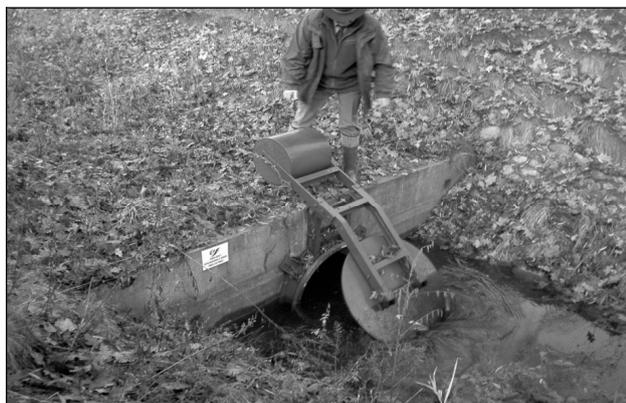
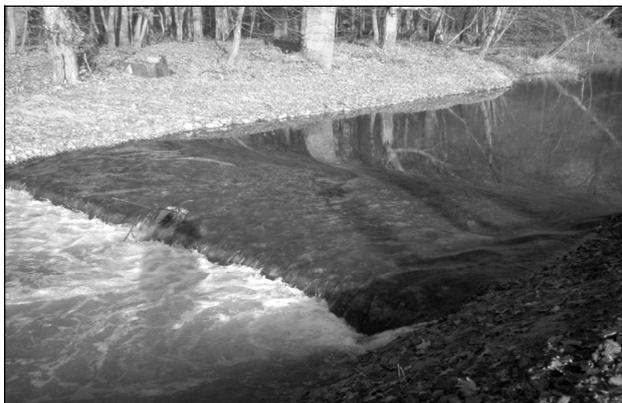
Fig. 3. The floodplain forests in Uroczyisko Warta Forest (a), culvert with a flap check valve (b), damming sill (c).

Active protection methods undertaken in Uroczysko Warta that employ simple technical solutions (flashboard gates, sills, culverts with flap check valves) are supposed to emulate natural hydrologic processes at the river valley bottom. However, river floods cause vertical recharge of groundwater, the implemented solution bases on horizontal groundwater movement in soil due to a rise of water level in oxbow lakes and storing water in dry channels. It can be assumed that groundwater levels in the area will gain lower level below ground surface for longer periods during the vegetative period in effect.
