Original Research

Change of Hydrological Regime and Water Quality Due to Reduced Wastewater Discharged into Surface Waters

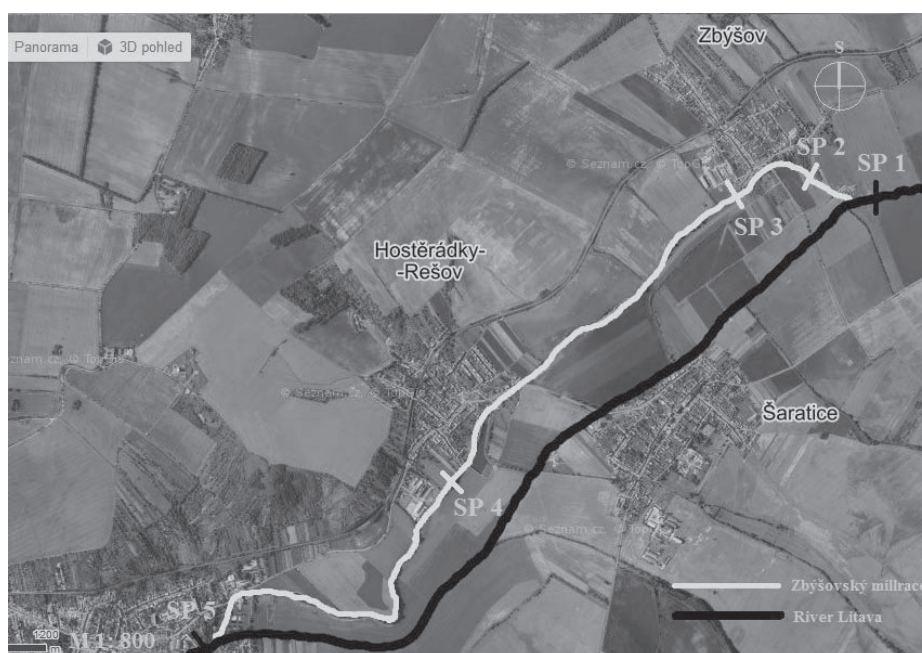
Fig. 1. Interest areas – sampling profiles (source: www.mapy.cz, edited by author).

assess the change in water quality of the millrace. These measurements were taken from December 2015 to December 2016. This span includes the period during which the inhabitants were gradually hooked up to the newly constructed sewerage network. The measurements were carried out regularly every month. These field measurements were supplemented by laboratory analyses of the samples taken. Water samples were taken with a periodicity of three months in December, March, June, September and December. A total of five sampling points was set: SP1 – Litava River, river km 18.7, before the millrace turned off. The second point of departure was the SP2 – the millrace, at river km 5.3 per mill. SP3 – the millrace, river km 4.6, behind the village Zbýšov. SP4 – the millrace, river km 2.1, behind the village of Hostěrádky-Rešov. River Litava SP5 river km 13.9, in the town of Újezd u Brna was chosen by the last sampling profile (Fig. 1).

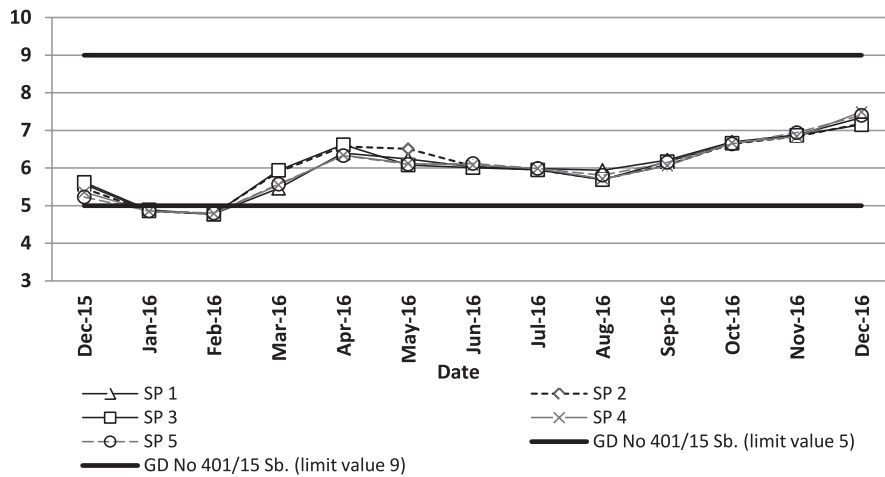
Fig. 2. pH course.

The pH value affects chemical and biological processes in water. Surface waters, apart from peat waters and acidified water reservoirs and lakes, have pH values ranging from 6.0 to 8.5 [15]. Annual measurements show a progressive increase in the pH segment in all measured profiles in the monitored section. The pH value stabilizes as neutral. Spring pH measurements show slightly alkaline values that are outside the EQS limit (min. value 5). These may be caused by increased supplements of discharged sewage

into the millrace (Fig. 2).

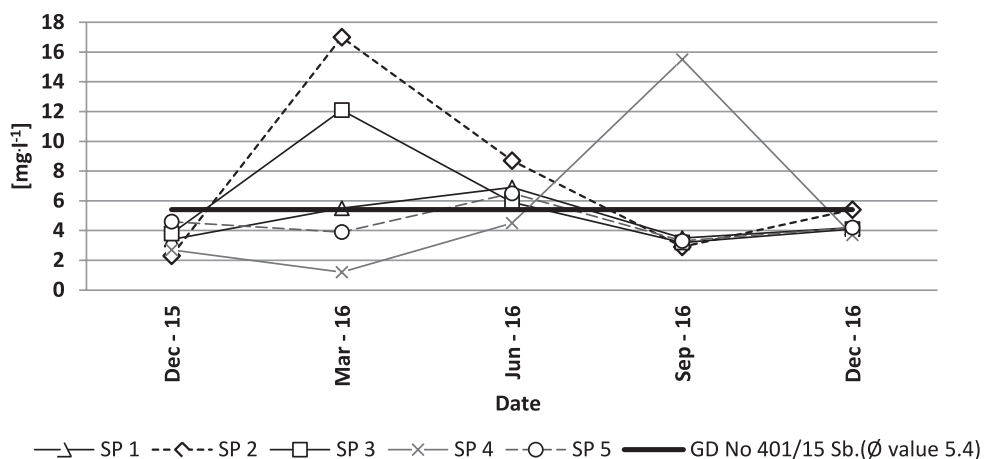
Fig. 4. Course of nitrate nitrogen concentrations.

Nitrate nitrogen is in the area of interest that oscillates around the limit of EQS (5.4 mg·l⁻¹ N-NO₃⁻). Profiles 1 and 5 are located in the Litava stream and are defacto control for Profiles 2, 3 and 4. These vary greatly during tracking. The second and third profiles from the second half of 2016 show comparable results; on the contrary, profile 4 shows the highest nitrate nitrogen values in September 2016 (Fig. 4). This value progression of nitrate nitrogen occurring in the millrace can be due to a more active connecting of households to the sewage system in the village of Zbýšov than in Hostěrádky-Rašov, which is evident from profile 4.

Furthermore, the concentrations of N-NO₃⁻ correspond to the total flow rate of the water in the millrace, which since mid-summer has been subsidized by total lower precipitation.
