Mapping and Monitoring of Landforms Evolution. Case study: Breasta Landslide (Southwestern Romania)

Keywords: landslide, mass movement, GNSS measurements, GIS, surface analysis, Southwestern Romania

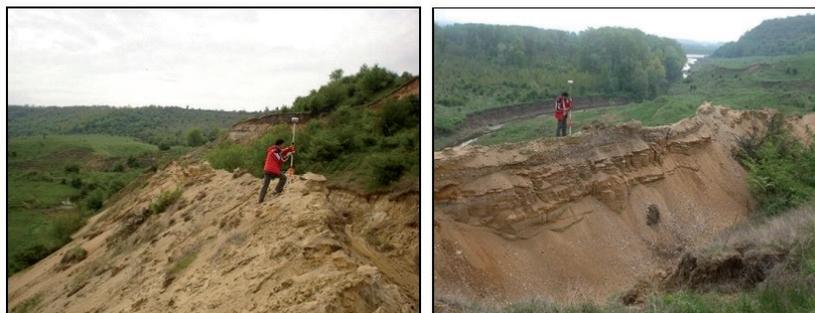
Fig. 7. Field monitoring – Breasta landslide (2011).

In 2006, we began monitoring the reactivation of the Breasta landslide by conducting field measurements to highlight its stage and trend of evolution. Field investigations, monitoring, and theoretical analyses were carried out. In total, 30 monitoring campaigns were completed (starting with spring 2006 and ending with autumn 2022). In general, the outings in the field were correlated with the periods in which the amount of precipitation in 24 recorded significant values (August 2006 and 2007; September 2014 and 2015; July 2018 and June 2019). The 3D model of the landslide was created following the measurement campaign in the spring of 2011 (see Fig. 6 and 7).

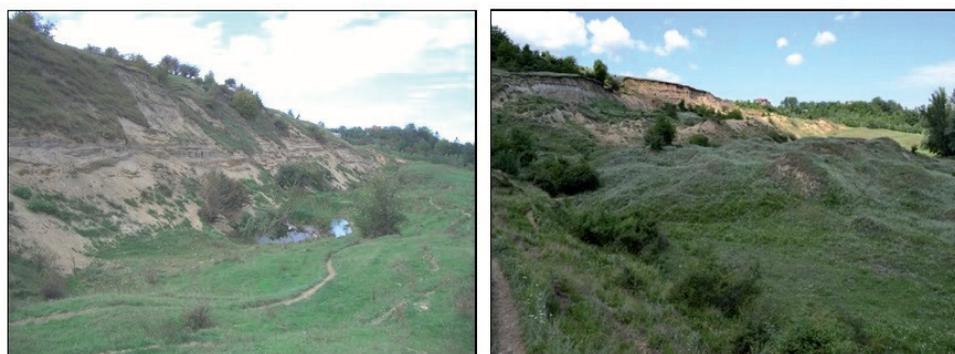
Fig. 8. Reactivation of Breasta landslide (2005 – left; 2011 – right).

The Breasta landslide occurred as a result of intensified erosion along the Jiu River's bank during years of excessive rainfall (see Fig. 8). It is a sliding landslide with rotational movements at its bottom. In the microrelief, 2-3 sliding steps and a frontal wave are separated. The detachment scarp is high (up to 8 m),

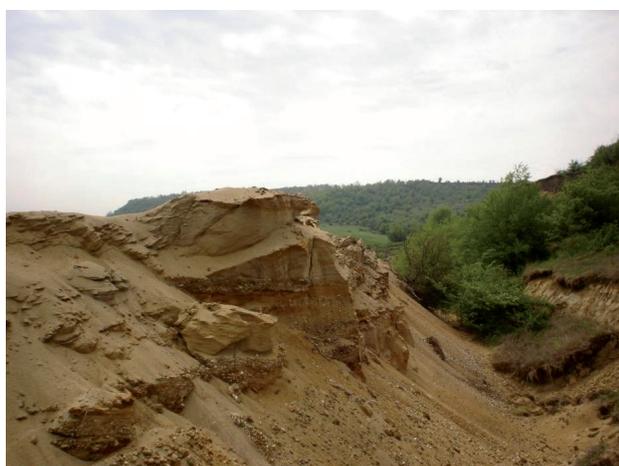
Fig. 9. New scarp of Breasta landslide after the reactivation in 2011.

What is more significant is that these heavy rainfalls occurred after five consecutive years with precipitation quantities below the annual average. GPS monitoring began in 2006, coinciding with a period of increased precipitation that caused substantial reactivation of the landslide. Subsequent GPS measurements, along the profile line, revealed the most significant morphological changes in the middle and lower sectors of the landslide, where the slope receded by 6 to 19 meters (see Fig. 9). Several depression-like areas, with excess moisture,

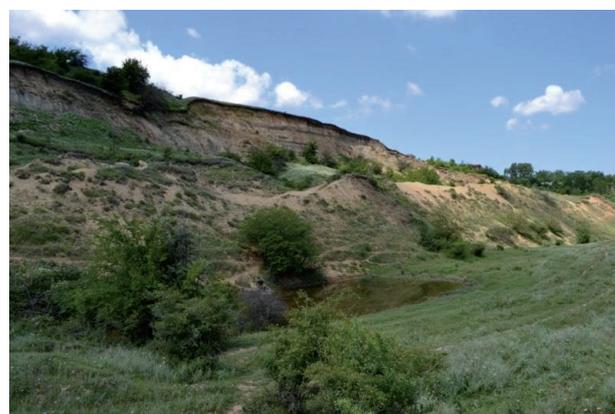
Fig. 10. Depression-like areas with excessive humidity, after the reactivation in 2011.

appeared after the reactivation, partially obstructing the Raznic River channel (see Fig. 10). The continuous instability of the landslide poses a flooding risk for the Breasta settlement. In the event that a larger portion of the landslide becomes active, it could block the course of the Raznic River, resulting in an increase in water levels upstream of the newly formed dam and thus the potential flooding of the Jiu and Raznic Rivers meadows, where the two villages are located.

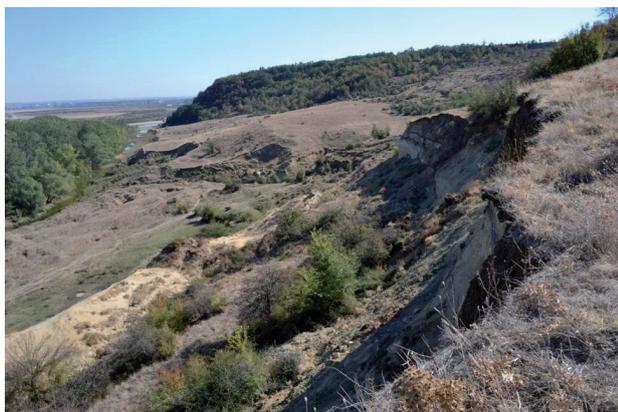
Fig. 14. Western sector of Breasta landslide (Spring 2011).

conditions (Spring 2011). According to the results, the western and central sectors of the Breasta landslide are the most vulnerable locations. The accuracy of the slope stability assessment was improved with a higher-resolution altimetric model (see Fig. 14 and 15).

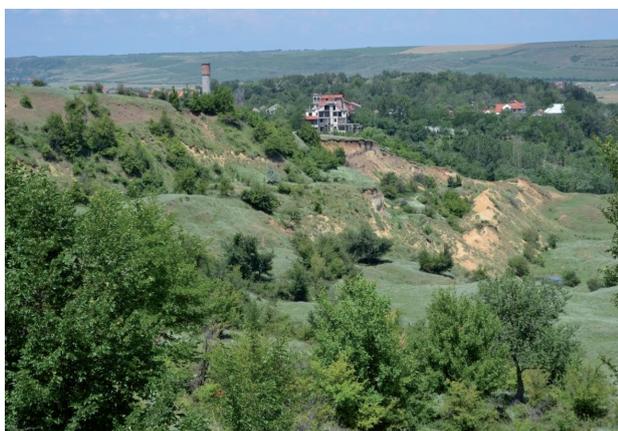
Fig. 15. Central sector of Breasta landslide (Summer 2011).
