Original Research

Physicochemical Properties of Soil around the MSW Dumpsite in North East Coast – A Sustainable Waste Management Practice

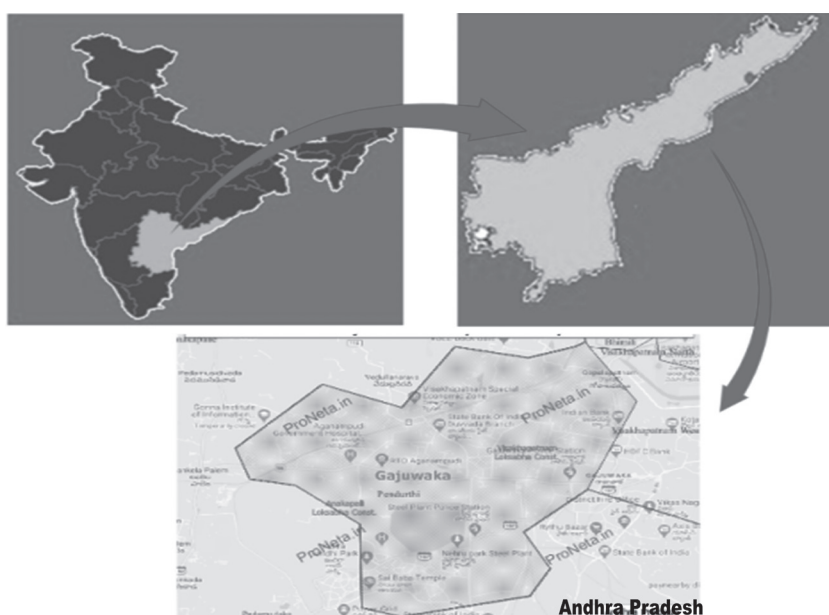
Fig. 1. Study area.

The Gajuwaka area MSW dumpsite was chosen for this research. This work aims to address these important challenges by emphasizing the importance of responsible waste management, data gathering, and the necessity for location-specific solutions to mitigate the ongoing environmental and health risks connected with MSW dumping. The study area is represented in Fig. 1.

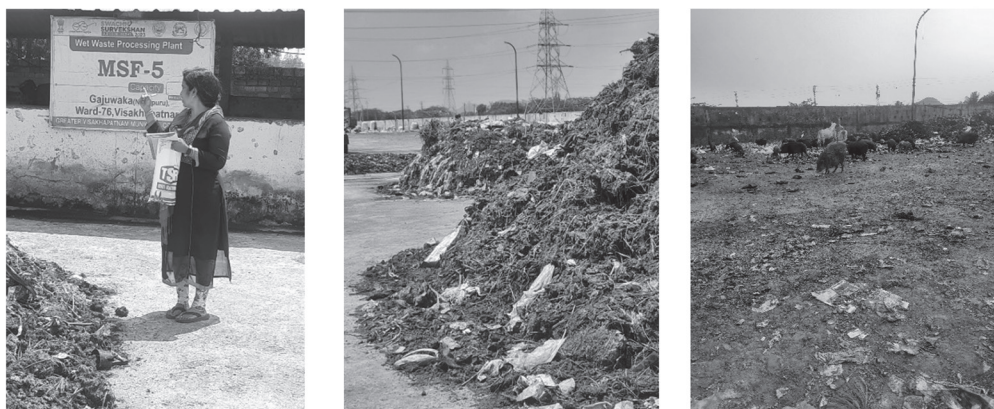
Fig. 3. Sample collection in various locations of the dumpsite.

These comprehensive methods and techniques provided valuable insights into the physicochemical properties and heavy metal accumulation in the studied MSW dumpsite. Fig. 3 represents the sample collection in various locations of the dumpsite.
