Using Geoelectrical Imaging to Recognize Zn-Pb Post-Mining Waste Deposits

Abstract

Keywords: Zn-Pb tailings, Olkusz, ERT, TDIP imaging, acid drainage

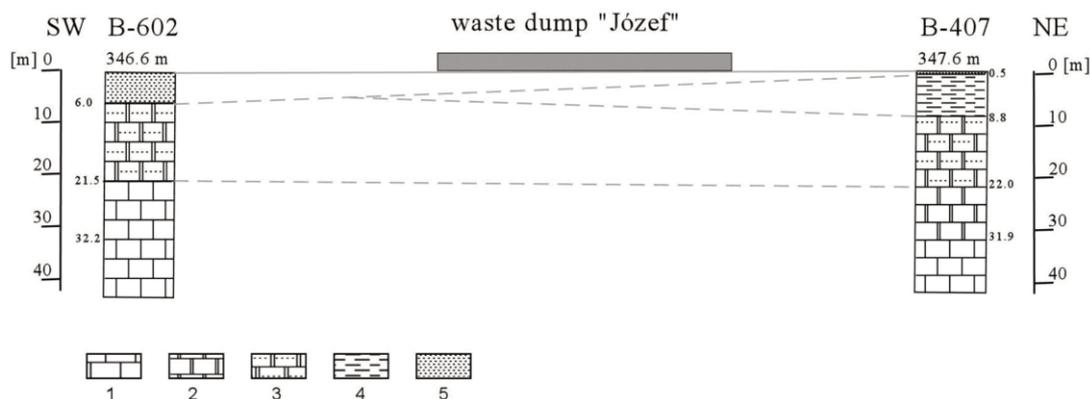
Fig. 2. The lithological profiles in the vicinity of the Józef washing plant:

1 – limestone (T_2), 2 – dolomite (T_2), 3 – diplopore dolomite (T_2), 4 – clay (Keuper, T_3), and 5 – dolomitical diluvium (Pleistocene).

situated at the foot of the waste dump, at the same level (347 m a.s.l.) as the archival boreholes in the geological cross-section. According to Fig. 2 the roof of the diplopore dolomite was expected to be at a depth of 6-8 m. Below this depth the resistivity and the normalized chargeability values obtained are not typical for those for carbonate rocks. The resistivity is low and the normalized chargeability is higher than those given in literature [32]. The diplopore dolomite does not contain ore minerals and thus the observed values may indicate a marly character of dolomites. Another possible reason for such a situation is the existence of pores and fissures in dolomites filled with the clayey particles, which were washed out of the overlying weathered sediments.

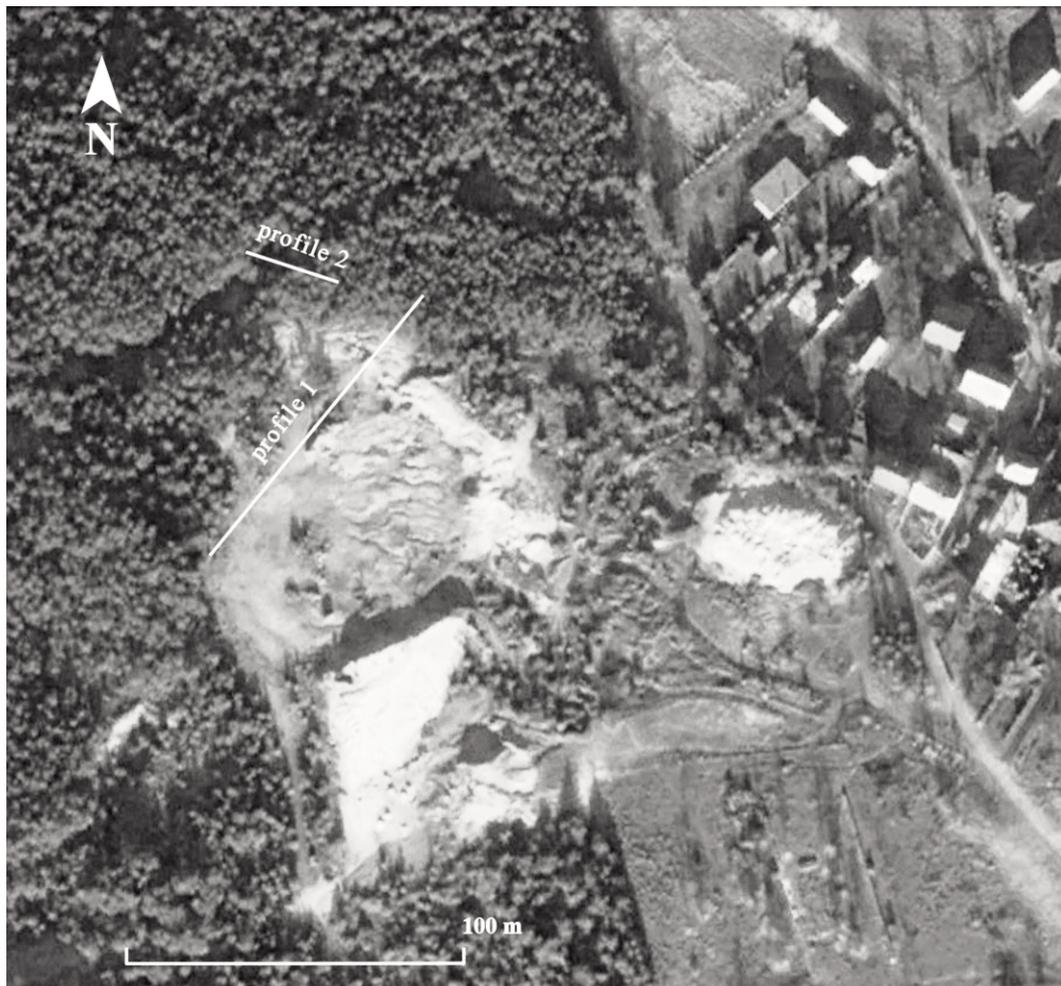
Fig. 3. The former washing plant Józef and location of geoelectrical profiles.

Two survey lines crossed the area of the earlier EM reconnaissance (Fig. 3). The first of these lines (profile 1)

was situated between piles, crossed both types of waste and its northeast end attained the unpolluted area. The second one (profile 2) was set in the area which according the EM survey had been identified as unpolluted. Resistivity and induced polarization data were collected using the dipole-dipole configuration with electrode spacing of 2.5 m for profile 1 (length of survey line 100 m) and 1.5 m for profile 2 (length of line 30 m). The initial applied current intensity was defined at 200 mA, and a minimum output intensity was set at 50 mA to obtain the best feasible data quality, which is important in the IP study. The assumed minimum current was not possible to be transmitted in the northern part of the profile. On that account for profile 2 the minimum intensity was reduced to 20 mA. The results of the resistivity and induced polarization inversion obtained with the use of Res2DInv software are illustrated in Figs. 4 and 5. Resistivity sections are presented in a uniform scale of colour. Induced polarization is shown in terms of normalized chargeability, which depends only on lithological factors such as mineral composition, grain fraction, porosity, and permeability [24].

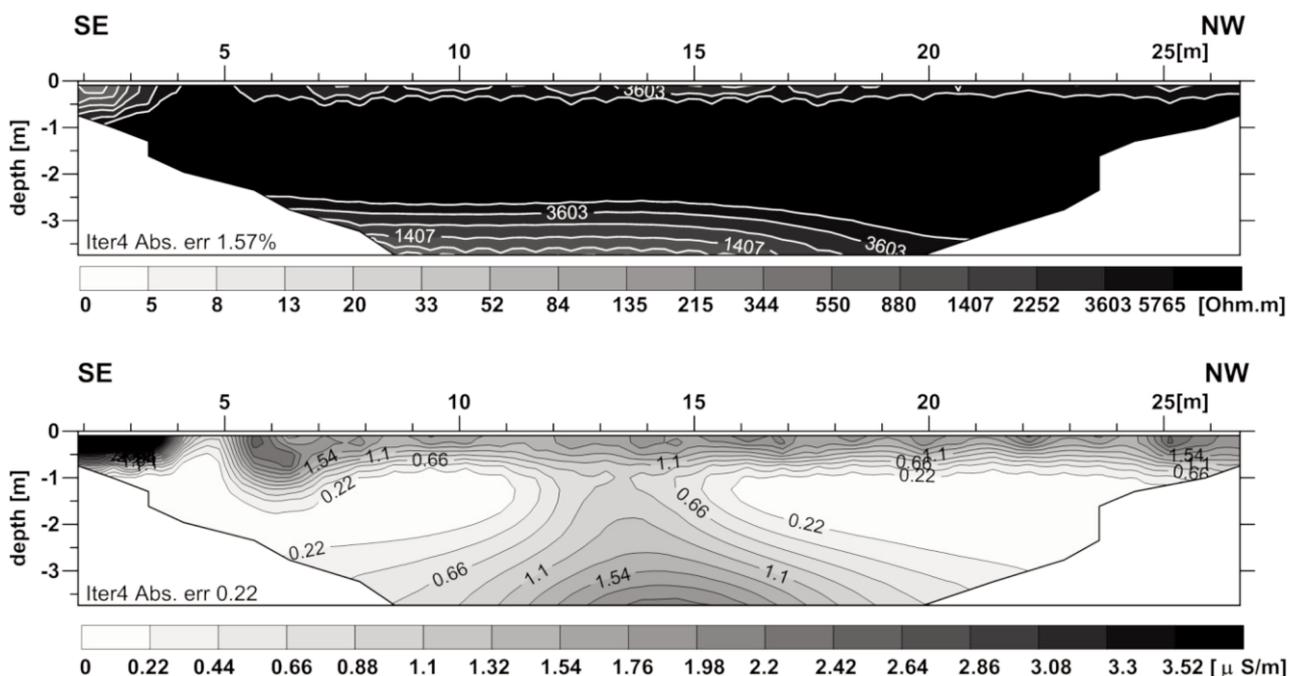
Fig. 4. The former washing plant Józef and inverted resistivity (upper) and inverted normalized chargeability (lower) sections obtained for profile 2.

Profile 2 was located in the unpolluted area according to the conductivity measurements [1]. For this profile only a shallow reconnaissance up to a depth of 3.5 m was conducted. The results obtained can be seen in Fig. 4. The resistivity for the whole search line is very high – considerably above 3 k Ω m, and the normalized chargeability is very low – below 2 μ S/m. These values are attributed to the Quaternary fluvioglacial sand present in the dump surroundings. The slight decrease of resistivity and increase of normalized chargeability is observed at a shallow depth only in the southern part of the section.

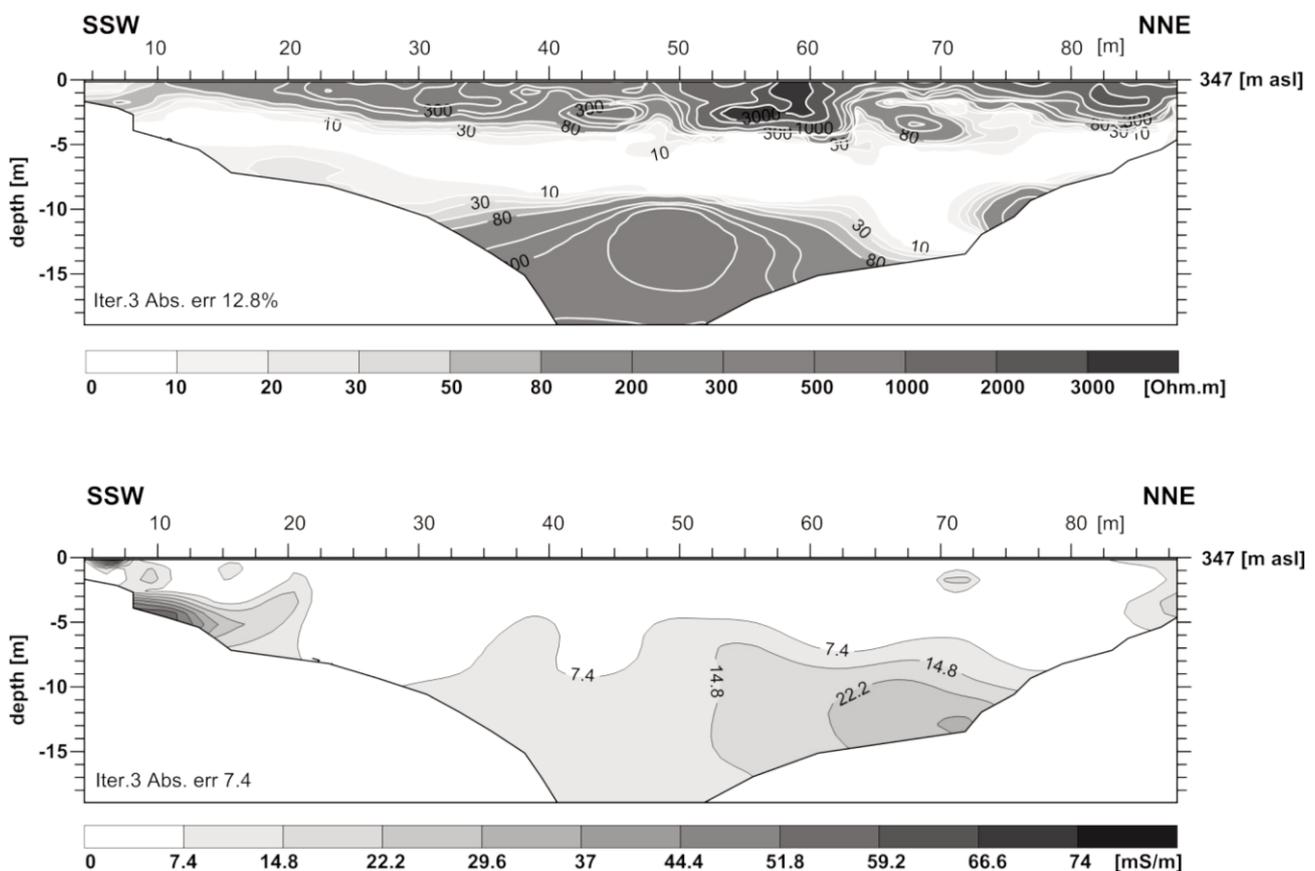
Fig. 5. The former washing plant Józef and inverted resistivity (upper) and inverted normalized chargeability (lower) sections obtained for profile 1.

The deeper resistivity section obtained for profile 1 exhibits a three-layer structure (Fig. 5). This search line was

In the cross-section, layer lying directly above the dolomite is a layer several meters thick that is characterized by resistivity in a range of 6-20 Ω m. The low resistivity only partially correlated with the increased normalized chargeability indicates that zones built of the clay or the clayey diluvium of the Triassic rocks in the surveyed area are noncontiguous and exist only in a fragmentary form as isolated pieces. In the studied area these sediments cannot shield the dumping site.

The top layer is built of the waste material deposited probably on the fluvioglacial sands. It can be observed that its thickness slightly increases from SW to NE, but does not exceed 2.5-4 m. This layer is characterized by different electrical properties than the clean sands. The resistivity values exceed 200 Ω m and increase to the northeast up to 2 k Ω m. The normalized chargeability is low in comparison to that ascertained for the deeper clayey sediments.

At a distance of 68-72 m of the profile the resistivity decreases significantly to the level of 20-30 Ω m at a depth of 1-2 m, and the resistivity decrease correlates with the

increased normalized chargeability. In this interval the grey waste is visible on the surface. The anomaly obtained possibly indicates a part of the grey waste rich in the unweathered Pb and Fe sulphides. After a long-lasting storage period, oxidation of the sulphide minerals in the top layer of rusty and grey waste is almost certain. Non-oxidized sulphides, especially galena and marcasite (sphalerite does not exhibit the induced polarization effect [32]), can exist only near the bottom of the waste layer. Within the rusty waste the initial content of the sulphides was considerably lower due to the ore initial composition, and the oxidation process was more intensive because of its significant permeability. In a consequence of long-lasting chemical transformations the Zn, Pb, and Fe ions were bound in non-polarizable carbonates that can be observed in the waste [1] and thus their vertical migration was limited. It can be found in literature [33] that the sands that exist below the rusty waste show considerably lower contents of metals and meet requirements established for industrial soils.

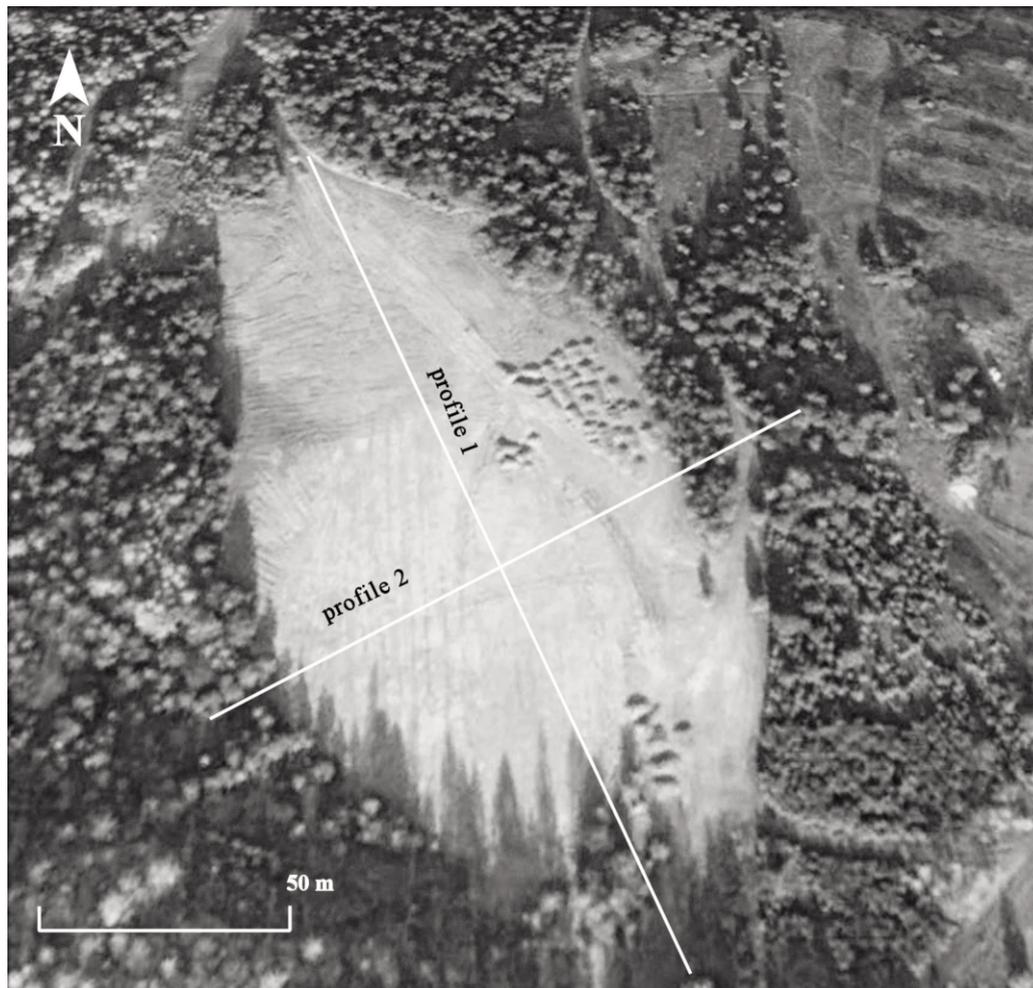
Fig. 6. Sinkhole No. 71 and the location of the geoelectrical search lines.

Two measurement lines were situated in the reclaimed area (Fig. 6). The first, with a length of 190 m and NNW-SSE direction, was traced parallel to the longer axis of the former sinkhole. The second perpendicular line was 140 m long. The smallest distance between the electrodes was established at 5 m. A minimal current intensity was 50 mA. In contrast to the Józef waste dump, at this site the field conditions were rather favorable for geoelectrical study as the upper soil layer was moist, which influenced the grounding of the electrodes and the electrical contact.

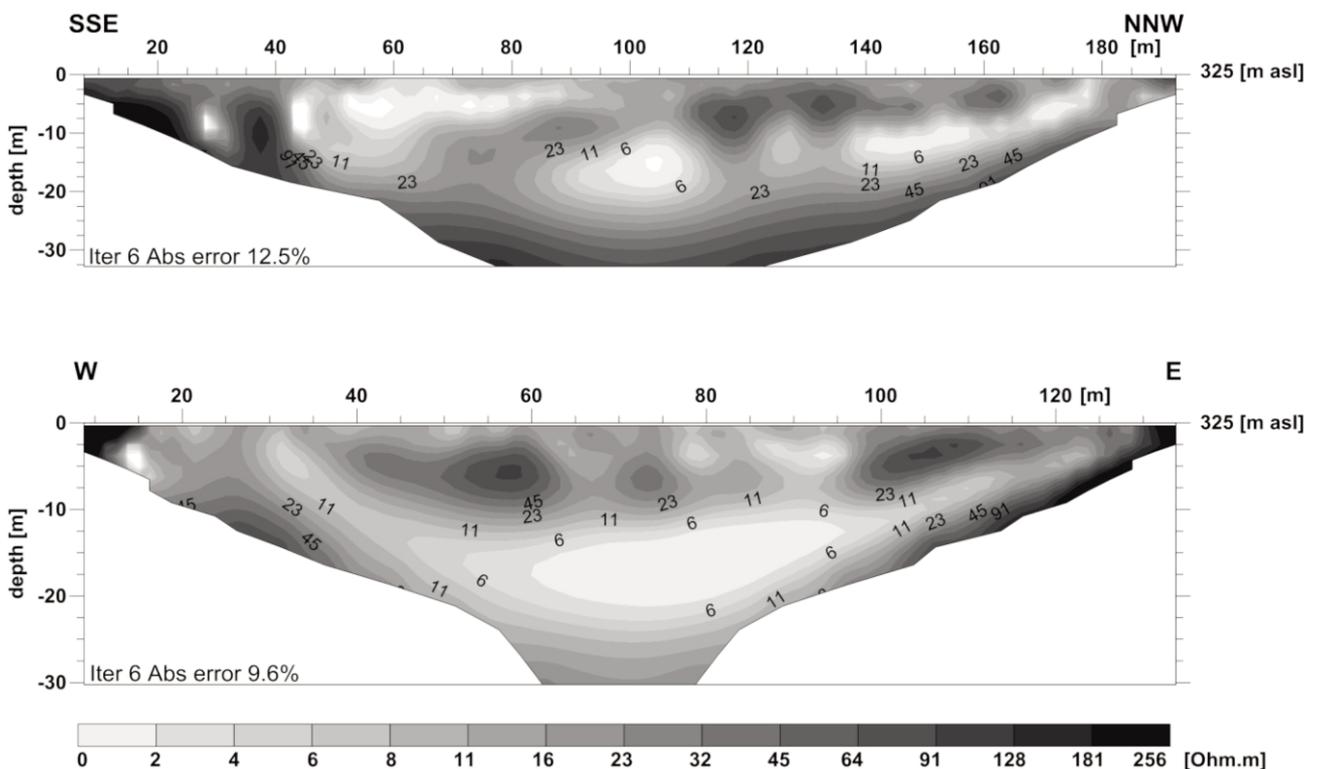
Fig. 7. Sinkhole No. 71 and resistivity sections obtained for profile 1 (upper) and for profile 2 (lower).

The depth of investigation for profiles 1 and 2 was about 25 m. At first, variations of electrical resistivity for both profiles were studied. Results obtained are presented in Fig. 7. For optimal visualisation, both maps of resistivity are plotted in the same standardized scale of colour.

The shape of the former sinkhole can be easily observed in both cross-sections. The existence of Triassic carbonate rocks can be seen as a moderate and highly resistive zone in the marginal and bottom parts of the sections. A steep slope of the sinkhole walls can be observed. The floor of the sinkhole cannot be recognized unambiguously due to its depth, which exceeds the range of the measurement, especially in the northern part. For profile 2 the sealing layer seems to be effective. The obtained results show no signs of the deposited material leaching out of the storage yard.

For both sections it can be observed that the filling material is characterized by a noticeable dual structure. Material stored at the bottom of the sinkhole exhibits very low resistivity ranging from about $1 \Omega\text{m}$ to $30 \Omega\text{m}$. For the upper part moderate resistivity values ($30\text{--}130 \Omega\text{m}$) are a distinctive feature, but the smaller areas characterized by very low resistivity can also be noticed. The tailings used for filling the hole before its utilization for many years had been stored. A time between the end of the reclamation process and the geoelectrical measurements was too short to enable the vertical differentiation of the waste (connected with the oxidizing of sulphides), thus the observed spatial changes seem to be an effect of the various electrical properties of the two kinds of the waste deposited – tailing near the bottom and slag in the top of the sink-hole.

The very low resistivities ($<4 \Omega\text{m}$) that are clearly observed in both sections are disconcerting, because they may indicate the presence of contaminated water within the waste or they can result from the mineral composition of the filling material.

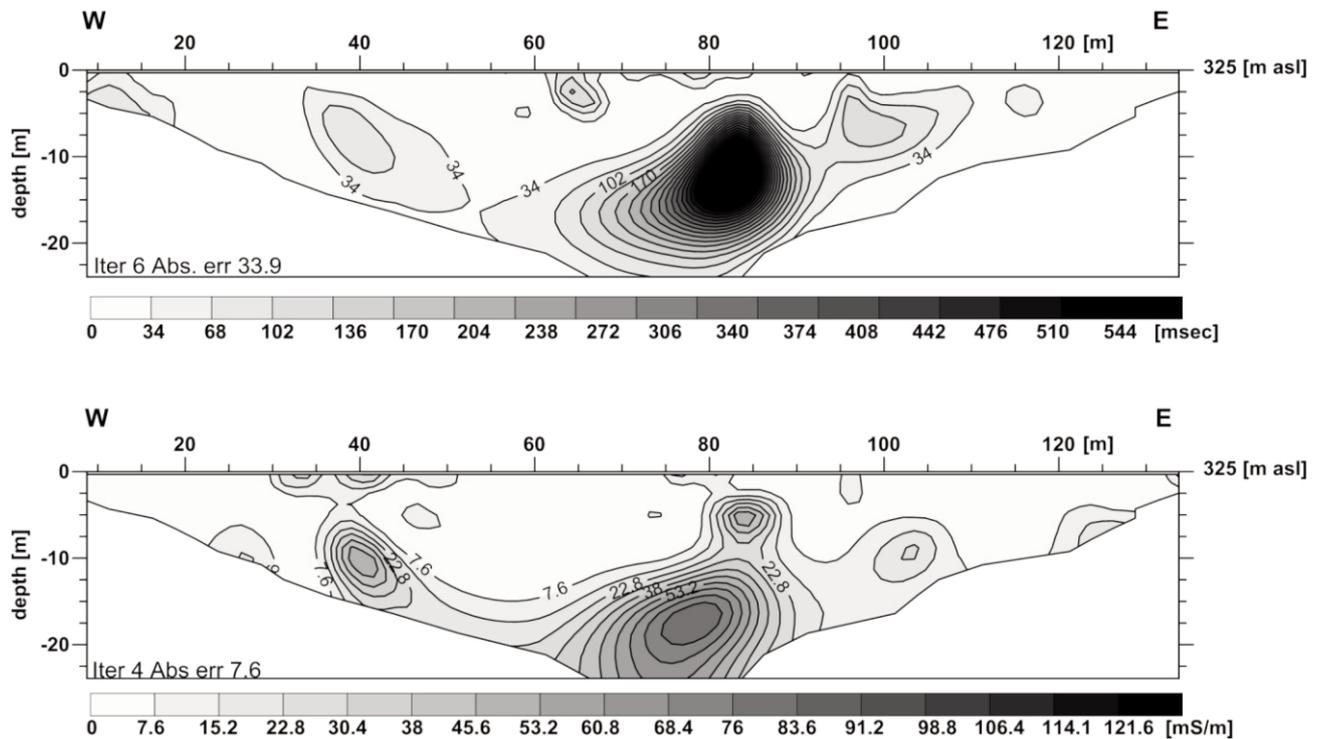
Fig. 8. Sinkhole No. 71 and inverted chargeability (upper) and normalized chargeability (lower) sections obtained for profile 2.

The induced polarization measurements that were conducted only for profile 2, where the strong low-resistive

anomaly is observed near the bottom of the sinkhole, completed the ERT results and allowed us to identify the reason of the recognized anomaly. The obtained sections of the inverted chargeability and normalized chargeability are presented in Fig. 8. After the analyses of these sections it can be easily observed that for the above-mentioned doubtful area the decreased resistivity corresponds with increased chargeability values. Thus, it indicates that the widespread, low-resistive zone in the bottom of the sinkhole is caused by the chemical composition of the stored tailings. High values of the normalized chargeability are caused by the marcasite presence (approx. 17%) and the content of dispersed clay minerals (up to 10%) in the waste [36].

In profile 2, starting from 120 m, near the surface the raised chargeability values do not correlate with the increase of the normalized chargeability. This feature can be considered as a zone of rainfall infiltration, but resolving this problem would require more detailed measurements across the edges of the sinkhole.
