Mine Subsidence as a Post-Mining Effect in the Upper Silesia Coal Basin

Grzegorz Strozik¹, Rafał Jendruś^{1,2*}, Anna Manowska¹, Marcin Popczyk¹

¹Silesian University of Technology, Faculty of Mining and Geology,
Akademicka 2A, 44-100 Gliwice, Poland

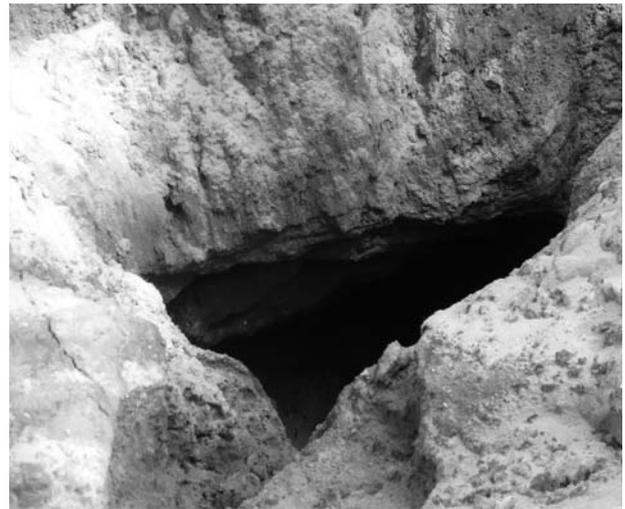
Fig. 1. Sinkhole subsidence in an area of shallow mining works at the JK mine in Jaworzno (photo: R. Jendruś).

However, direct field observations in the area of prospective road construction works exhibited evidence of sinkholes in the ground (Fig. 1), which was further confirmed by advanced exploration using ground-penetrating radar (GPR) and microgravimetry methods. As a result of these measurements, it was discovered that the subsoil foundation as well as deeper strata contain significant

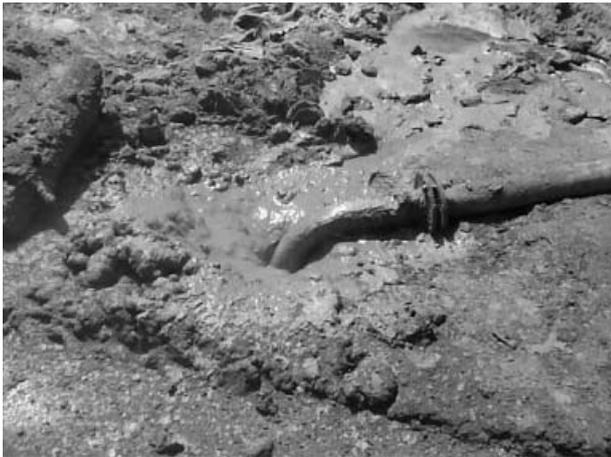
Fig. 2. Grouting works on the DP motorway construction site (photo: R. Jendruś).

Grouting of the voids was implemented to repair the ground foundation and eliminate the subsidence hazard. A line of 32 boring up to 30 m deep was drilled with respect to geophysical measurement results [9]. The voids were filled with a mixture of a commercially available mineral binder (based on activated fly ash) and water, with the use of low-pressure injection (mostly free gravitational flow; Fig. 2).

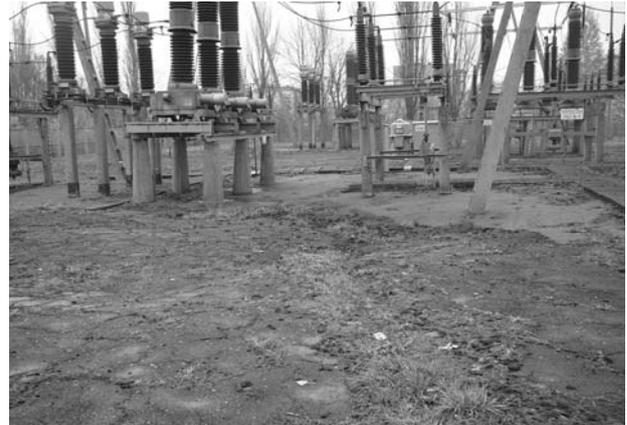
Fig. 4. Sinkholes and tilted poles at the Julian Power Distribution Centre (photo: R. Jendruś).

At the PDC plant, which was built in 1972, small sinkholes have been observed, resulting in tilting of poles of overhead high-voltage lines, couplings, and switches, which endangered the facility and jeopardized power to thousands of consumers (Fig. 4).
