Disappearance of Lake Jelenino Since the End of the XVIII Century as an Effect of Anthropogenic Transformations of the Natural Environment

This study presents the contribution of reclamation works to the disappearance of Lake Jelenino. On the basis of cartographic materials from the 19th and 20th centuries, as well as historical records, it was possible to establish that the lake of area 495.2 ha disappeared as a result of precise actions aimed at creating new settlements. Reclamation works proceeded in two stages. After the first stage, which took place in 1778-86, the area of Lake Jelenino was reduced by over 360 ha. In the 1970s the reservoir, whose area then amounted to 130 ha, was completely dried. Such a transformation of the natural environment was followed by social and economic changes – inhabitants of Jelenino village, who until then lived by fishing, in a short period of time retrained for agriculture and breeding.

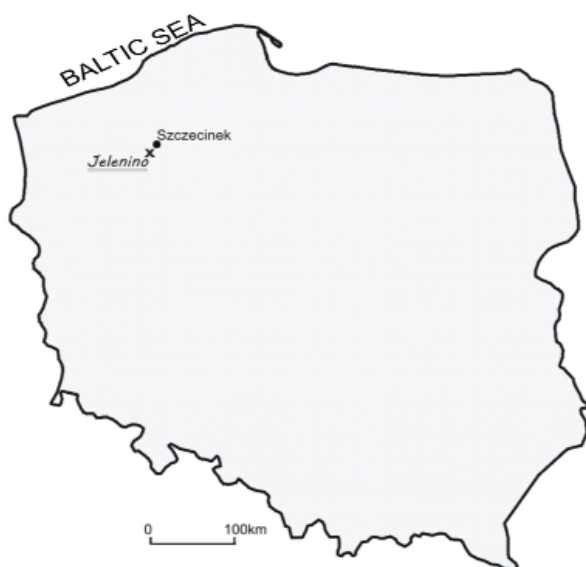
Fig. 1. Location of the study area.

The studied reservoir was located in northwestern Poland, near the town of Szczecinek, in the Drawskie Lake District (Fig. 1).

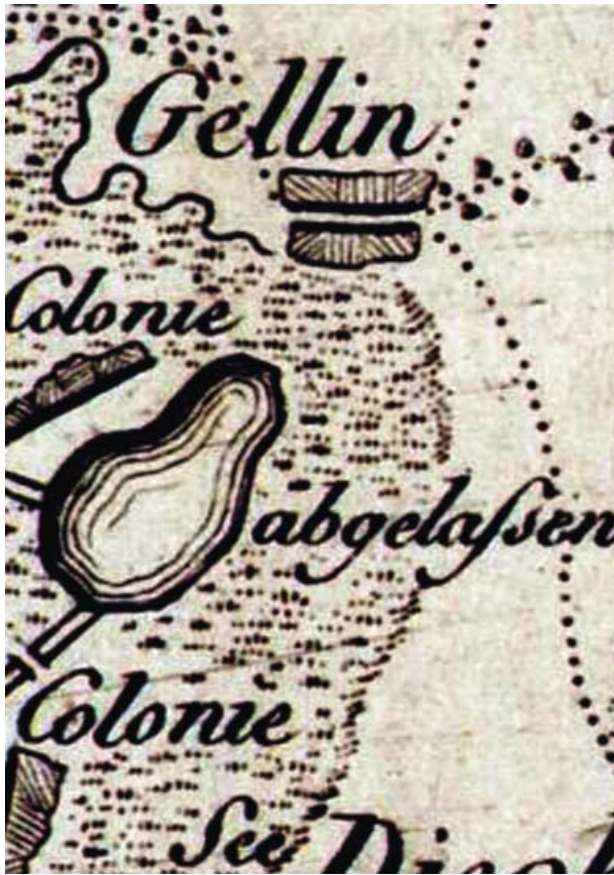
Fig. 2. Fragment of the map Karte des Konigl. Preuss. Herzogthums Vor – und Hunter – Pommern (1789) with partly dried up Lake Jelenino.

At that time the lake was drained by a few reclamation ditches located in the northern and western parts of the lake – water flew to the remaining fragment of the lake and further toward the south to Jeleń Lake.

The reclamation treatments of Lake Jelenino started in the XVIII century. After the ordinance of Frederick William II, the King of Prussia, the reservoir was considerably drained in 1778-86. As a result, two new small settlements were raised: Auenfelde (at present Przyjezierze) and Wilmshorst (at present Jelonek). Meadows and fields accessible after reclamation amounted to almost 500 ha and were passed on to new settlers while houses and farm buildings were financed by the King of Prussia [20]. The area covered by Lake Jelenino after the first stage of reclamation is presented in Fig. 2.

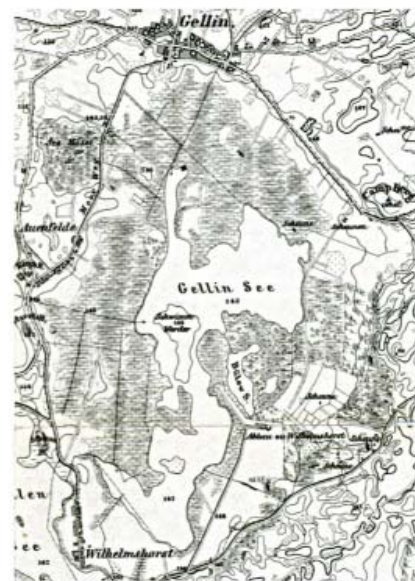
Fig. 3. Area covered by Jelenino Lake: a) based on the Urmesstischblatter map, b) based on the Messtischblatter map, with the original lake area established from the Messtischblatter map.

The topographic map Messtischblätter on the scale of 1:25,000 (from the second half of the 19th century) was used to assess the original area of Jelenino Lake (Fig. 3). The assumption was made that the coastline before reclamation works corresponded to the range of peat bogs and swampy grasslands visible at the Messtischblätter map.

It has been established that the area of Lake Jelenino in the 18th century amounted to 495.2 ha. It was a considerably large natural reservoir. According to Choiński [22], recently only 76 lakes in Poland exceed the area of 500 ha, and 26 of them (including 9 coastal lakes) are located in the Pomeranian Lake District. Therefore, if Jelenino Lake still existed, it would be one of the largest lakes in Poland. Hydrotechnical works performed over the years 1778-86 caused the water level to decrease by around 2 m. Taking into consideration the current location above sea level (around 139 m a.s.l.), the maximum depth of Jelenino would amount to 5 m. The decrease in water level resulted in the reduction of lake area by over 70% – down to 130.5 ha.

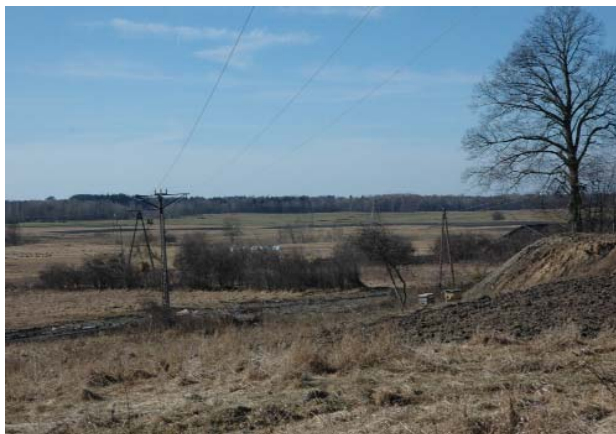
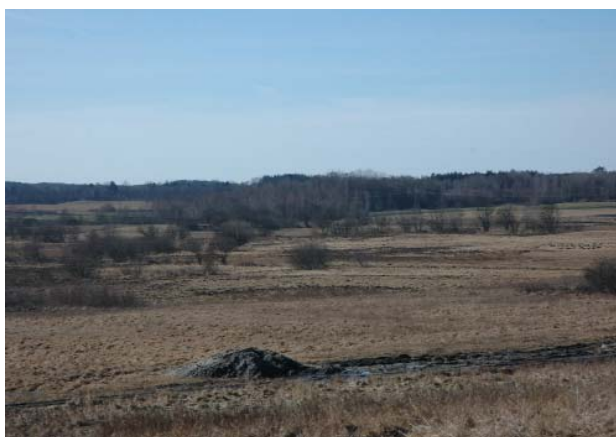
Fig. 6. Agricultural land at the area of non-existent Lake Jelenino.

The net density of reclamation ditches increased and the drained area was adapted for agricultural use by former fishermen who retrained for horse trade. Grasslands exist up to now thanks to the reclamation system, which still works (Figs. 5 and 6).
