The Durability of Reinforced Concrete Structures with 35 Years of Service in Offshore Environment

Dejun Fu*

Ningbo City College of Vocational Technology, Ningbo 315000, China

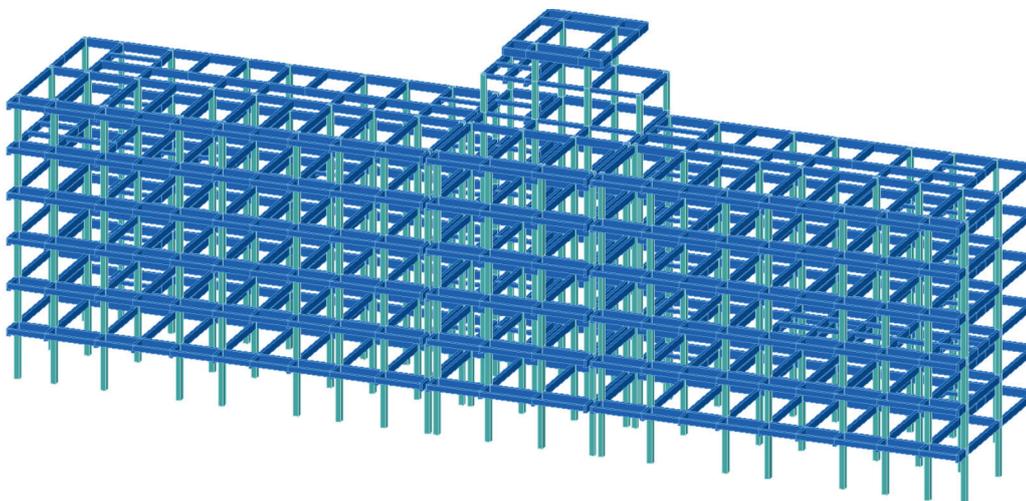
Fig. 8. Structural calculation model of the house.

This paper was to analyze the actual compressive bearing capacity of concrete beams and columns, whose strength was designated as 19 MPa based on the on-site investigation results. The structural calculation software PKPM was used to check the bearing capacity and the results showed that the main members in several places (22 sites on the 1st floor, 8 sites on the 2nd floor and one site on the 3rd floor) failed to meet the requirements stated in Article 5.2.2 of GB 50292-2015 that the ratio of the bearing capacity of concrete structural members to its effect should reach a_u level. The details are given in Table 5. The bearing capacity of
