# The Durability of Reinforced Concrete Structures with 35 Years of Service in Offshore Environment

Dejun Fu\*

Ningbo City College of Vocational Technology, Ningbo 315000, China

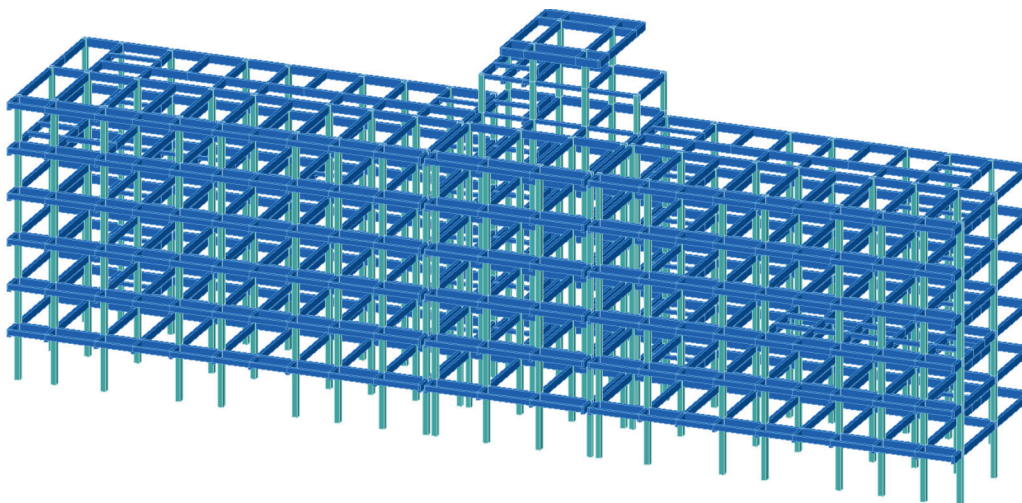
Fig. 8. Structural calculation model of the house.

This paper was to analyze the actual compressive bearing capacity of concrete beams and columns, whose strength was designated as 19 MPa based on the on-site investigation results. The structural calculation software PKPM was used to check the bearing capacity and the results showed that the main members in several places (22 sites on the 1<sup>st</sup> floor, 8 sites on the 2<sup>nd</sup> floor and one site on the 3<sup>rd</sup> floor) failed to meet the requirements stated in Article 5.2.2 of GB 50292-2015 that the ratio of the bearing capacity of concrete structural members to its effect should reach  $a_u$  level. The details are given in Table 5. The bearing capacity of
